Hazard Mitigation  
Grant Program  
(HMGP) project  
number 4340-0054:  
Coral Bay Hydrology  
and Hydraulics (H&H)

Final Report  
September 2023

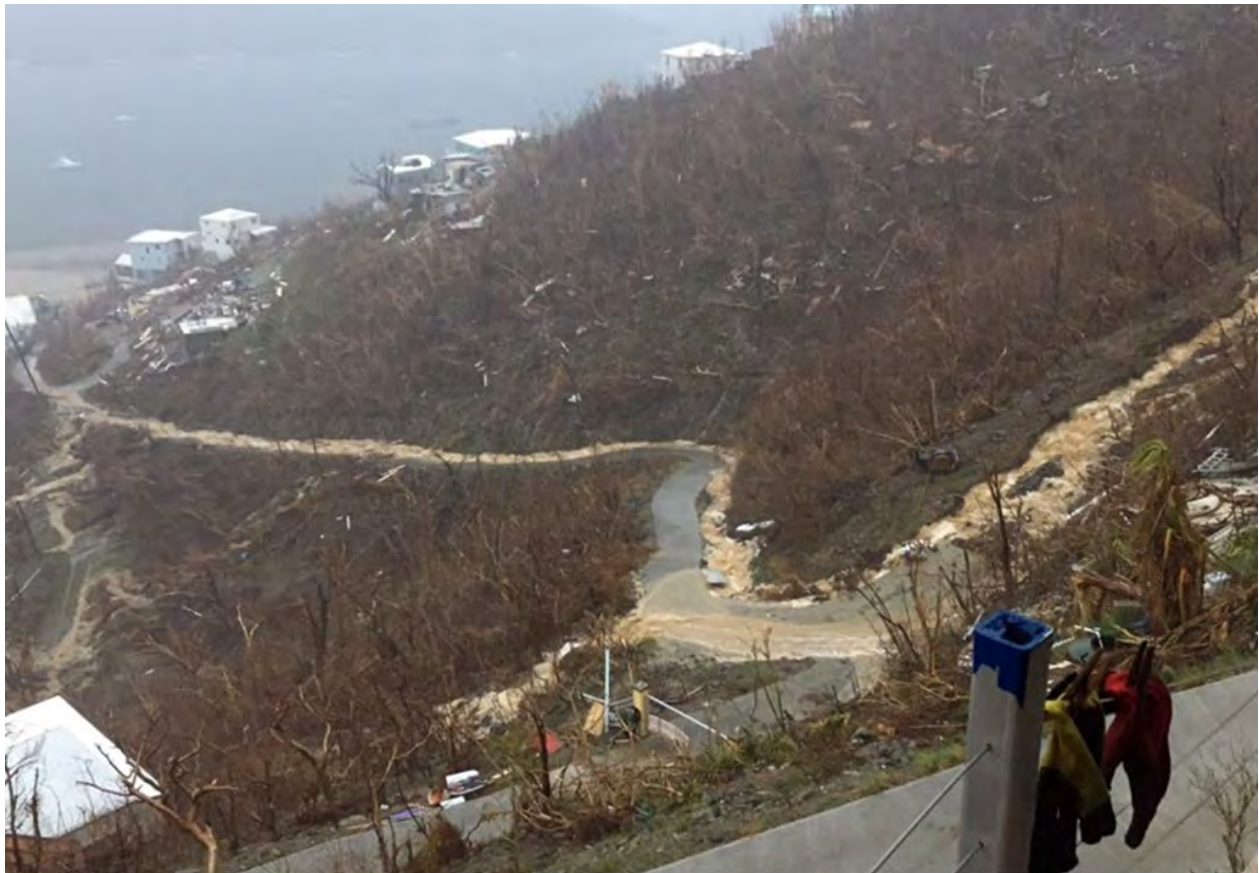
**Figure 2. Pollutant laden stormwater runoff often flows down roads as development has redirected flows away from guts (photo by CBCC).**

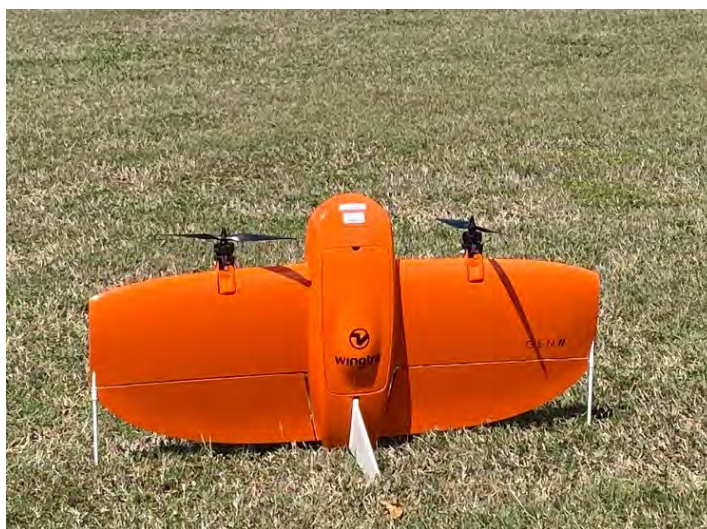
**Figure 3. A WingtraOne Gen II UAS was used to collect up to date very high-resolution imagery in key areas.**

This updated dataset better reflected current watershed conditions but was only current through 2019. As such, additional data was collected via a fixed wing WingtraOne Gen II (Figure 3) unmanned aircraft system (UAS). This UAS was used to collect very high spatial resolution imagery over key areas of the study area in March of 2023. Data collection was focused on areas where changes in land cover were expected or suspected to have occurred since the 2019 imagery was collected with a focus on drainage areas for priority projects (see Section 9).

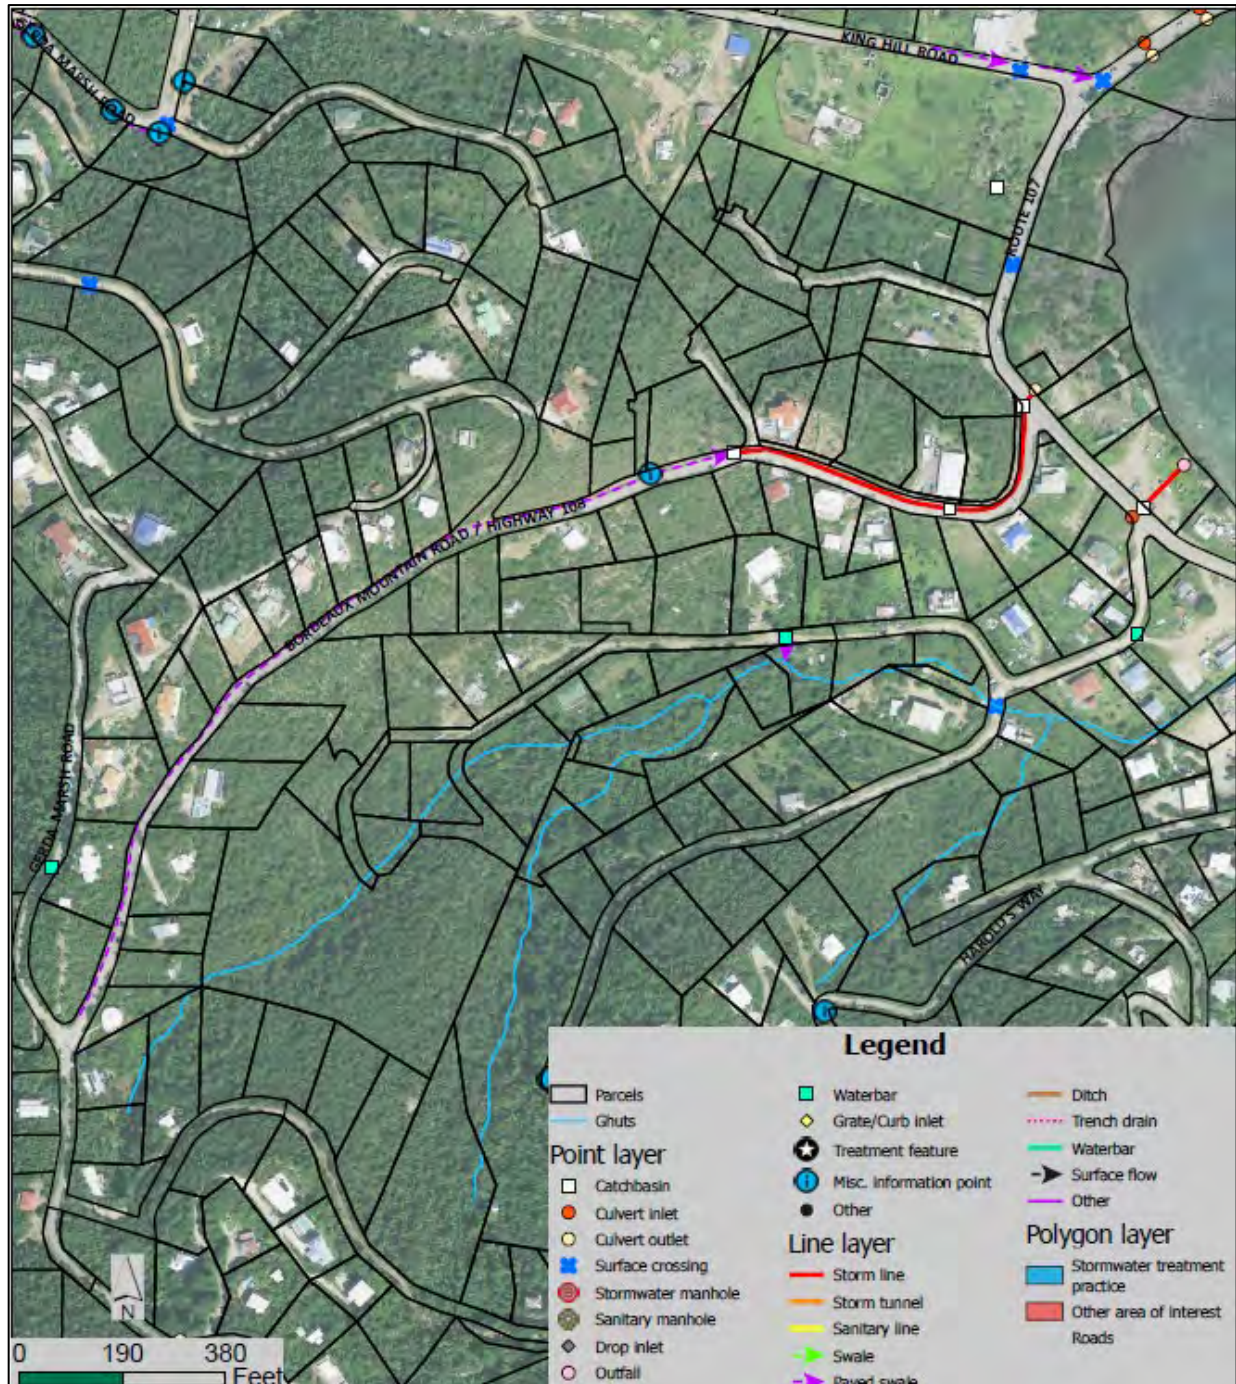
**Figure 4. An example of the infrastructure data that was mapped in 2022.**

This dataset is the most complete and accurate mapping of the stormwater infrastructure within the watershed. An example of this data for one select area can be found in Figure 4. However, no mapping of this scale can capture all infrastructure. There are many private areas that were unable to be accessed in the field. It is also expected that there is some infrastructure that has become buried with sediment over time and is unable to be identified. As-built plans were unavailable, so in areas where field investigations were unable to be completed or where pipe connections were unclear, this data was unable to be captured.

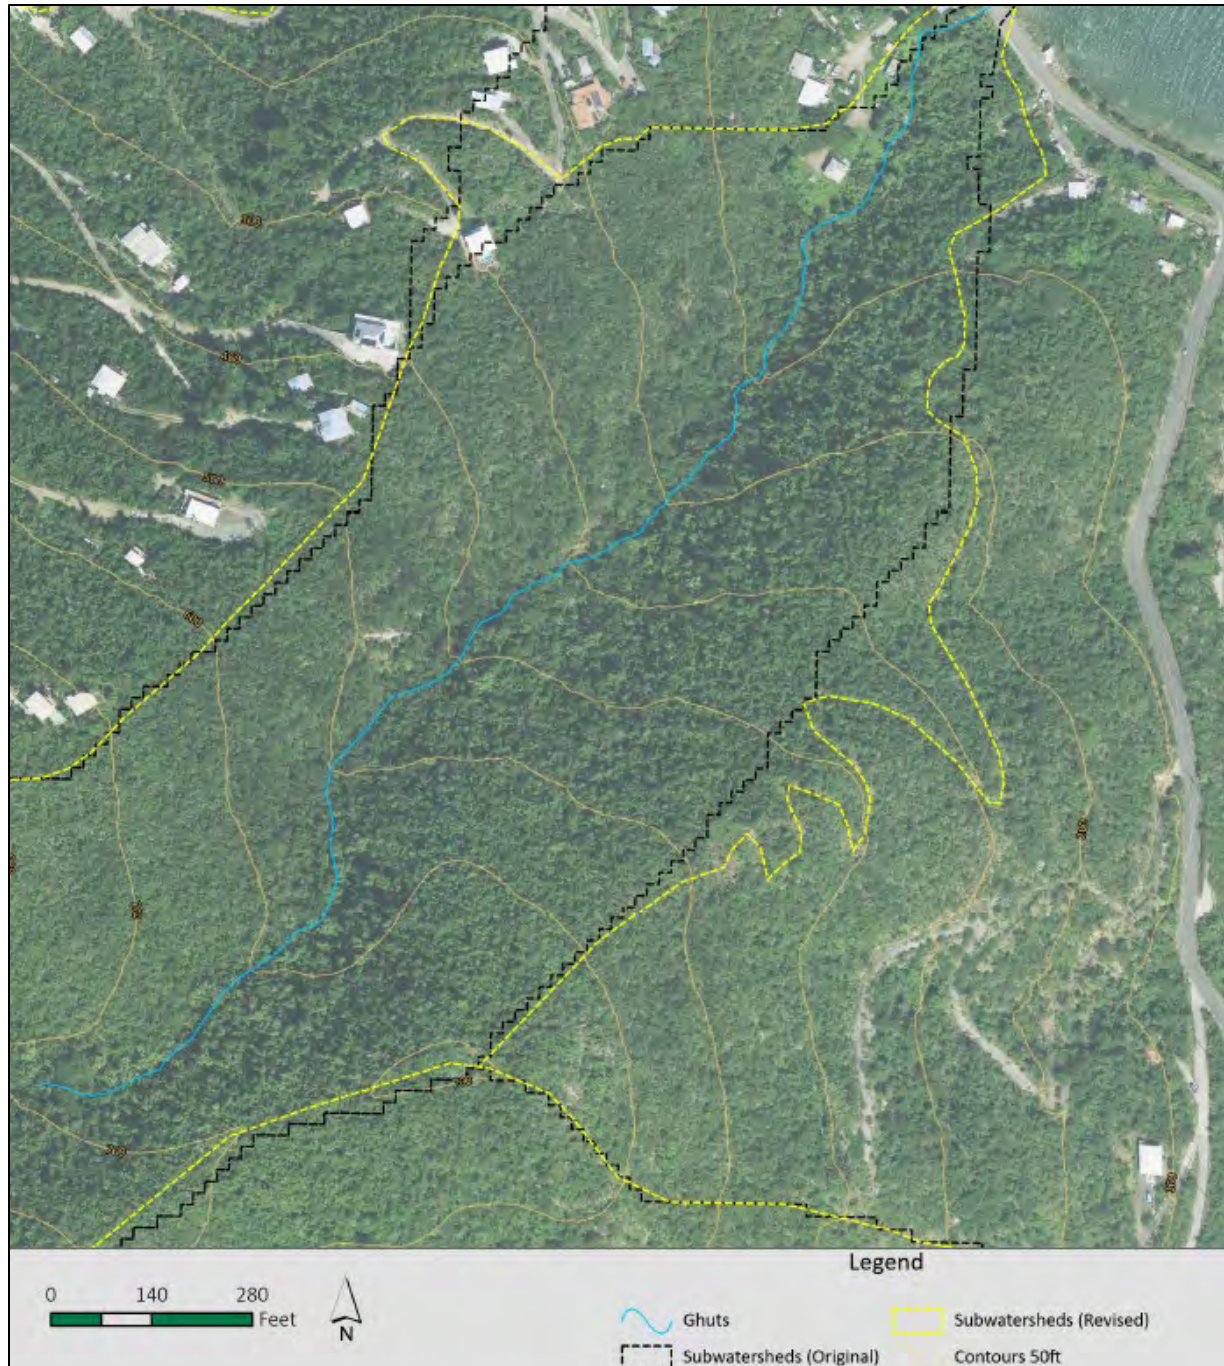
**Figure 5. An example of revisions (yellow) made to previous subwatershed boundaries (black) to reflect a better understanding of drainage patterns.**

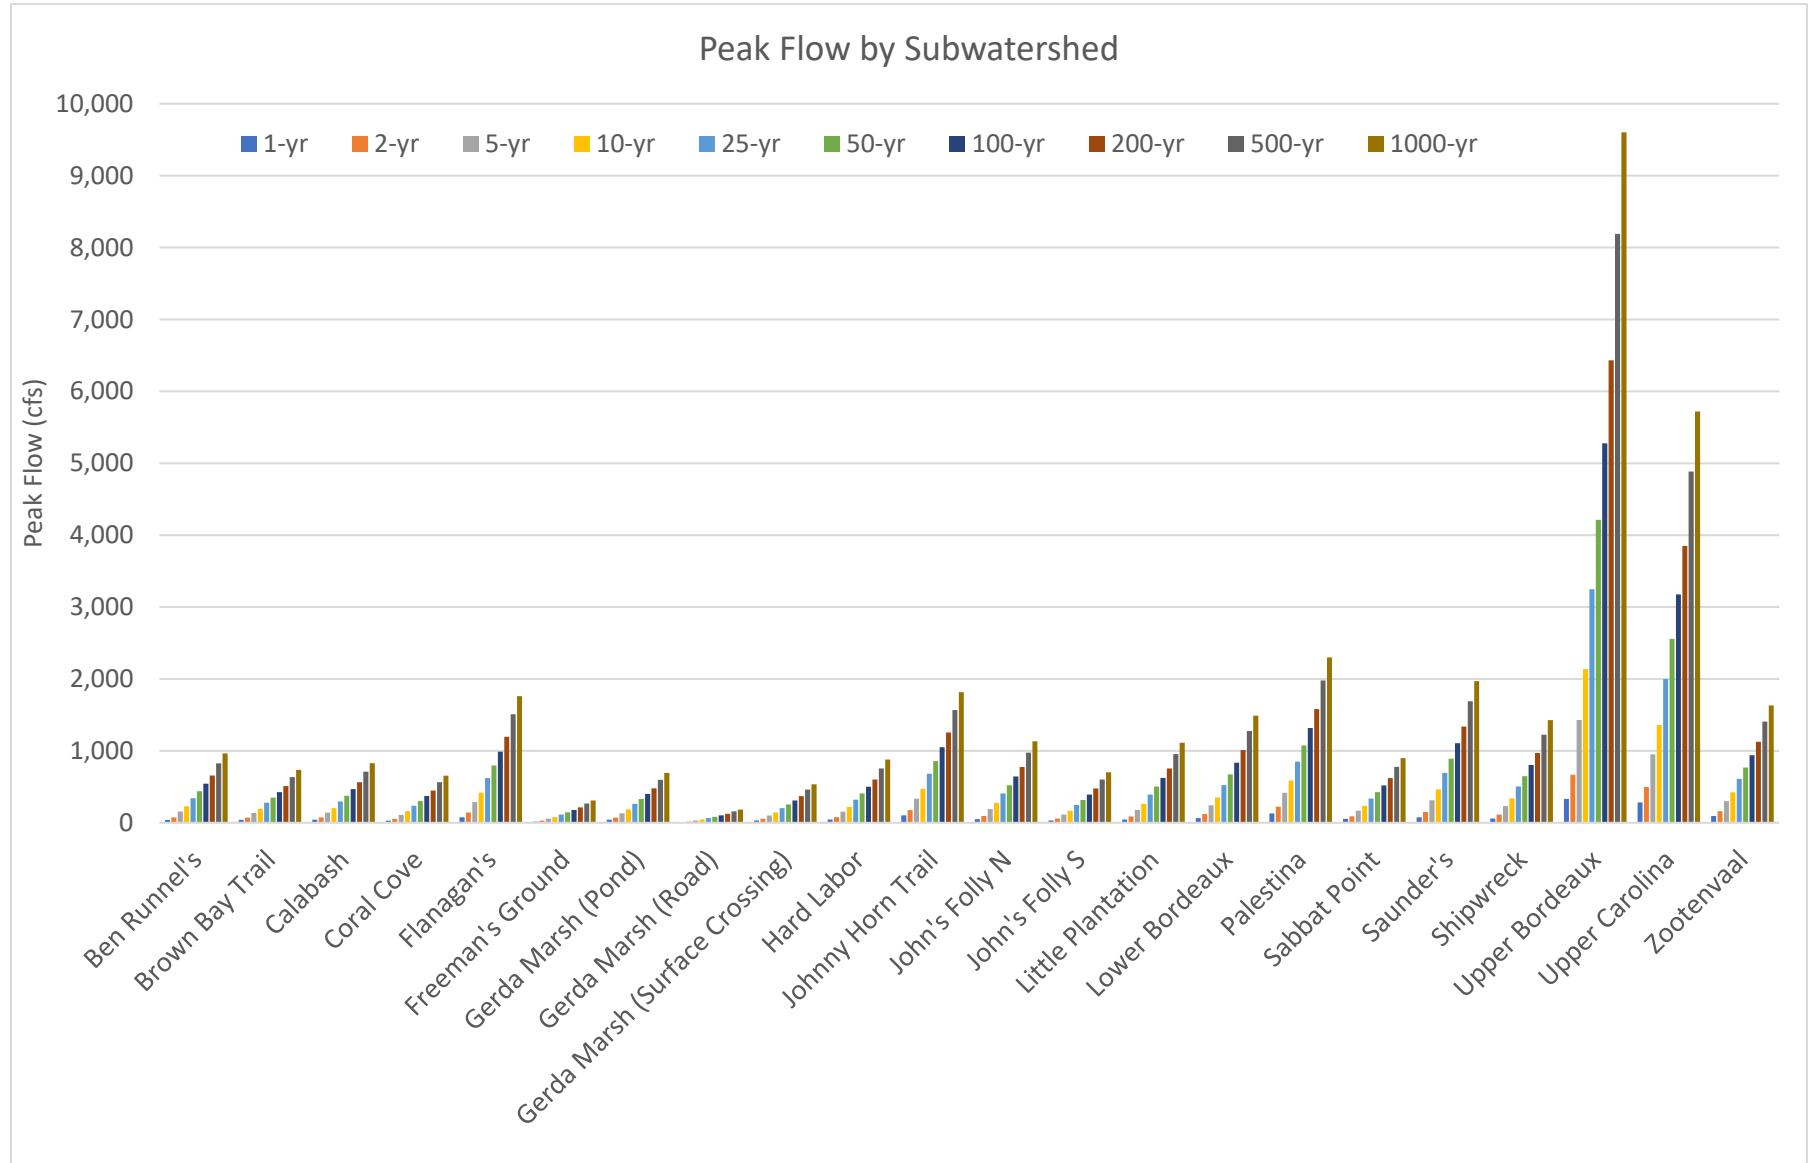
**Figure 6. Graph summarizing the modeled peak flows (cubic feet per second or cfs) by subwatershed for multiple recurrence intervals.**

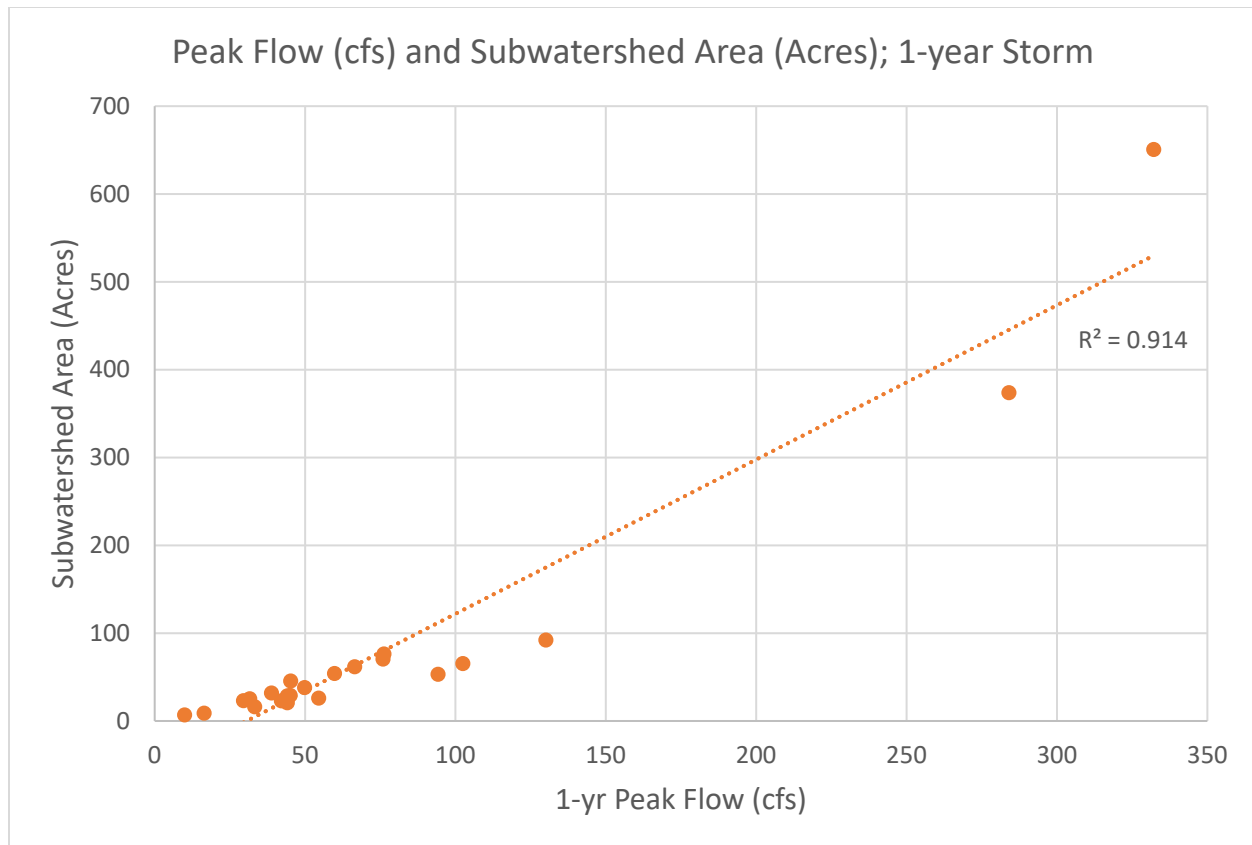
**Figure 7. Subwatershed area is well correlated to peak flow. An  $R^2$  value of 0.914 means that the line of best fit explains a significant amount of the variation in the peak flow values (91.4%).**

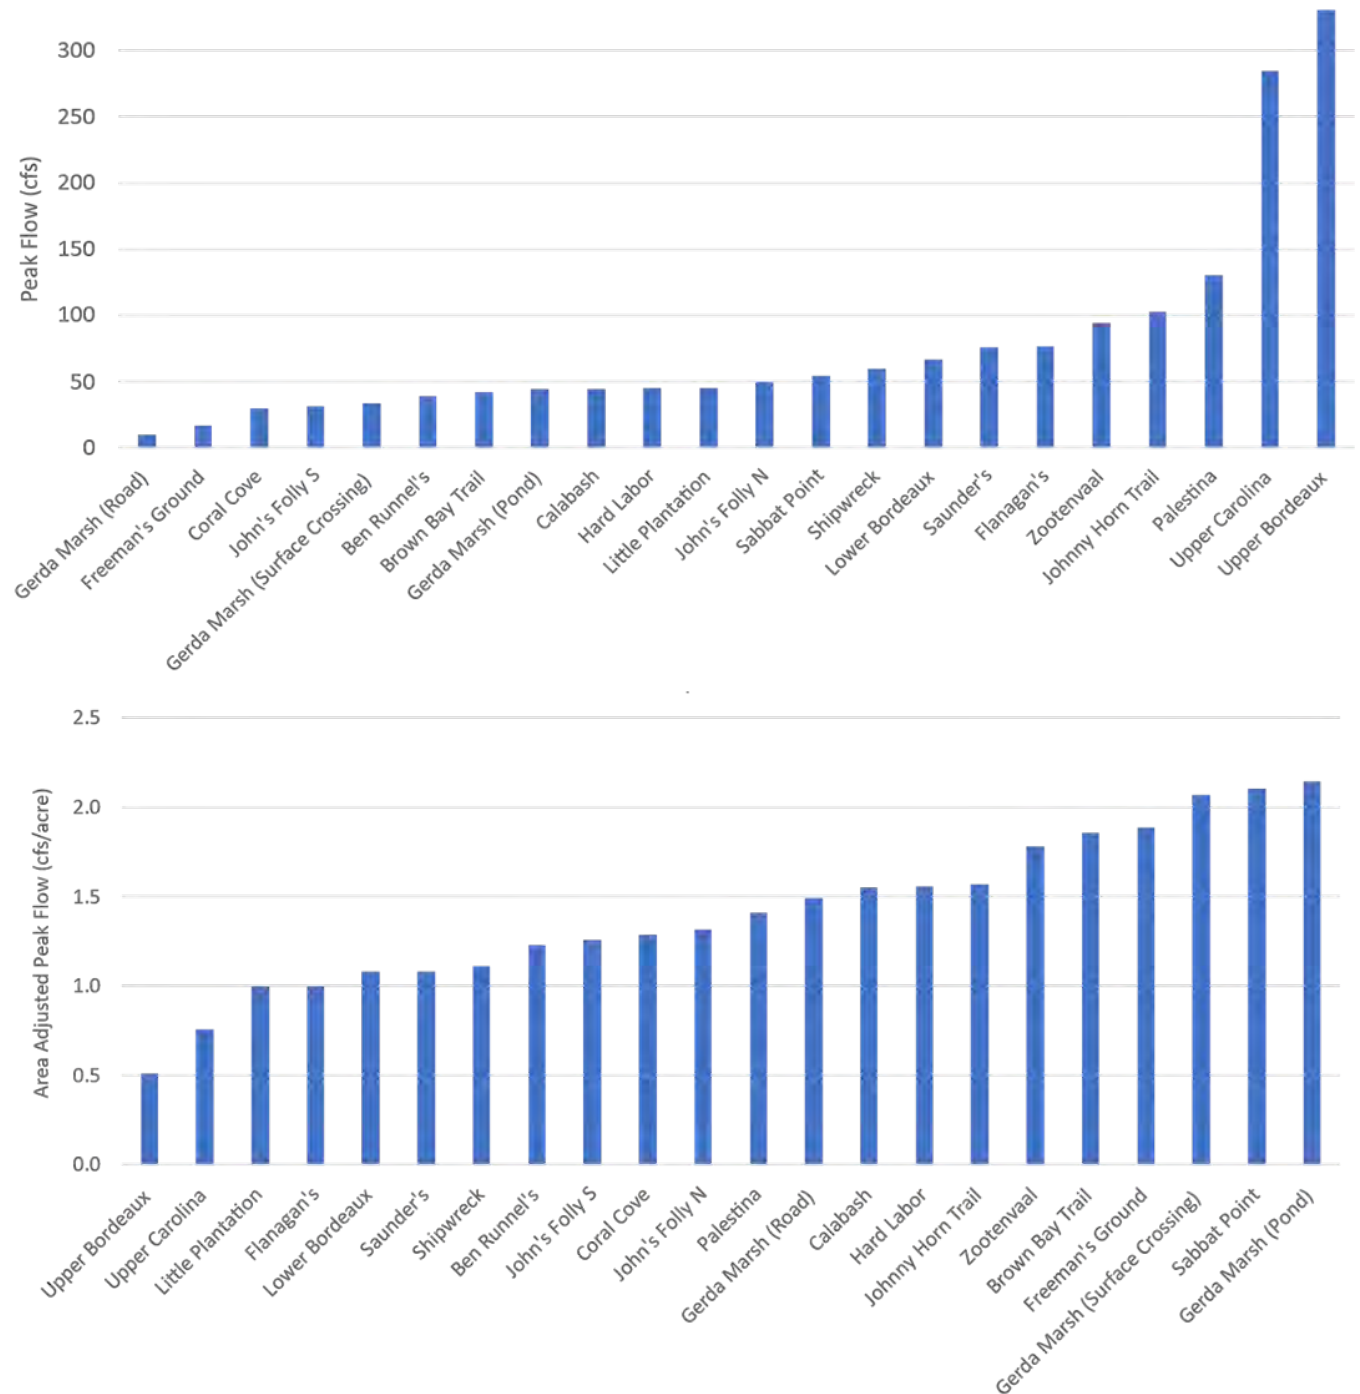
**Figure 8. Peak flows (cfs) for the 1-year storm event as modeled (upper) and adjusted by the subwatershed area (lower).**

If other inputs were equal, it would be expected that peak flows when adjusted by area would be consistent across all subwatersheds. However, as shown in Figure 8, the highest peak flows from the modeling (upper) are seen in different subwatersheds when normalized by area (lower).

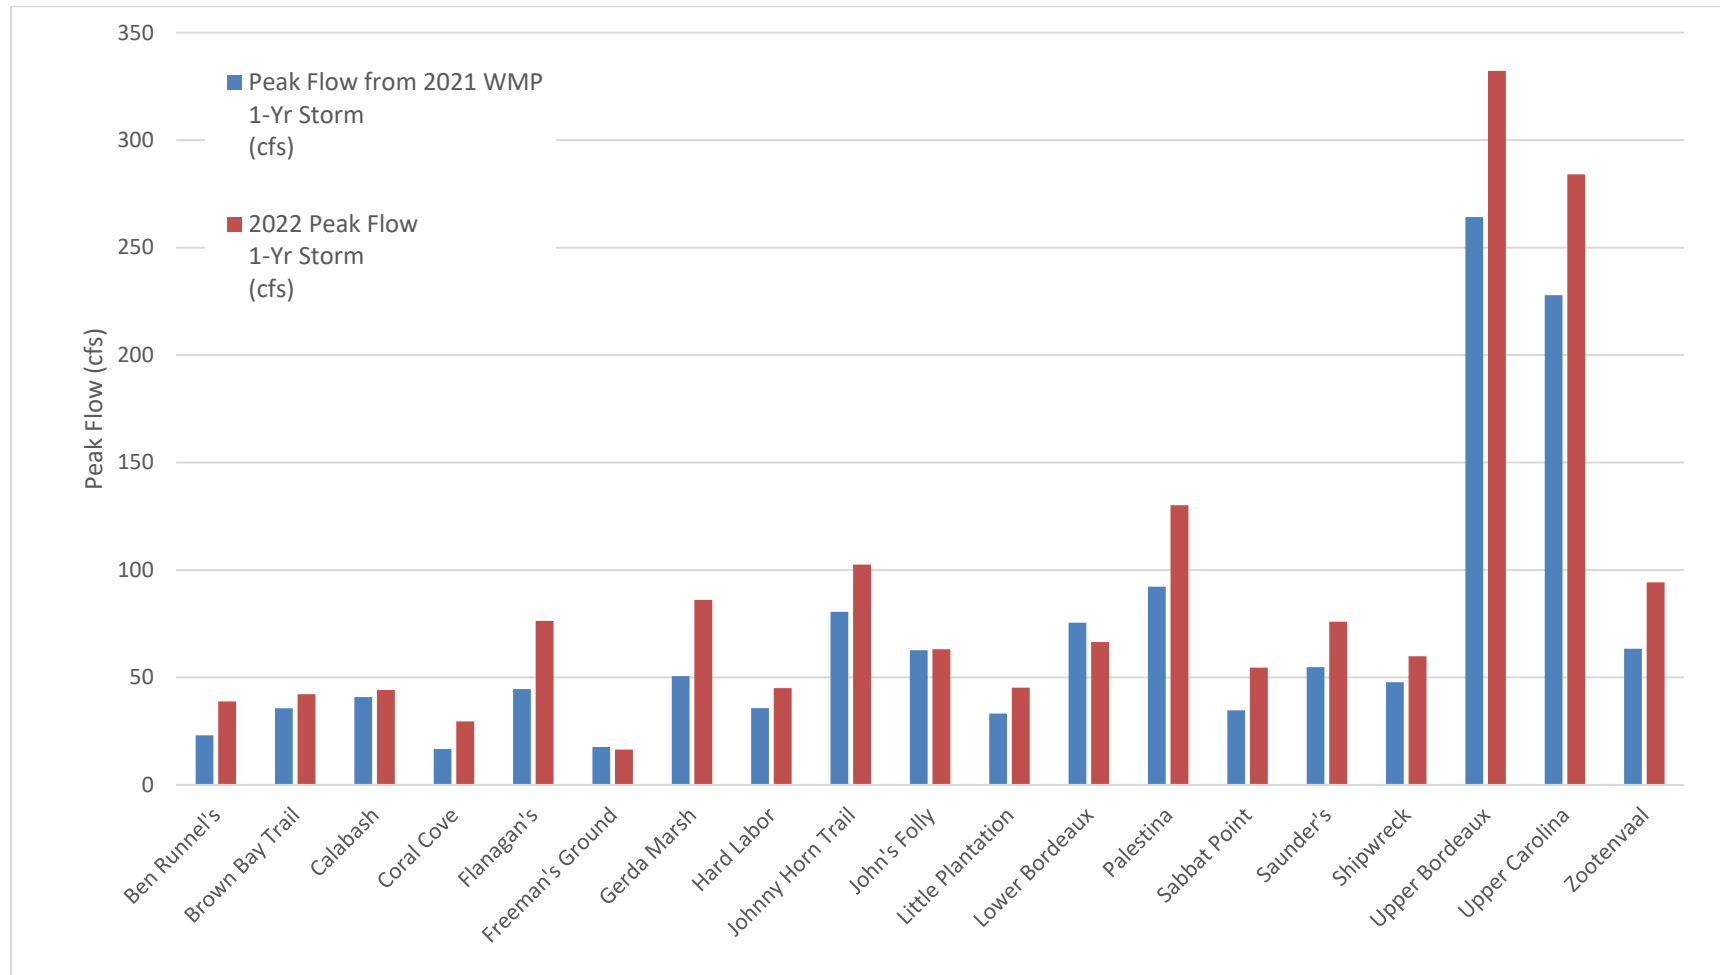
**Figure 9. A comparison of peak flows (cfs) from the 1-year storm event as modeled in the 2021 Watershed Management Plan (blue) and with updated data in 2022 (red).**

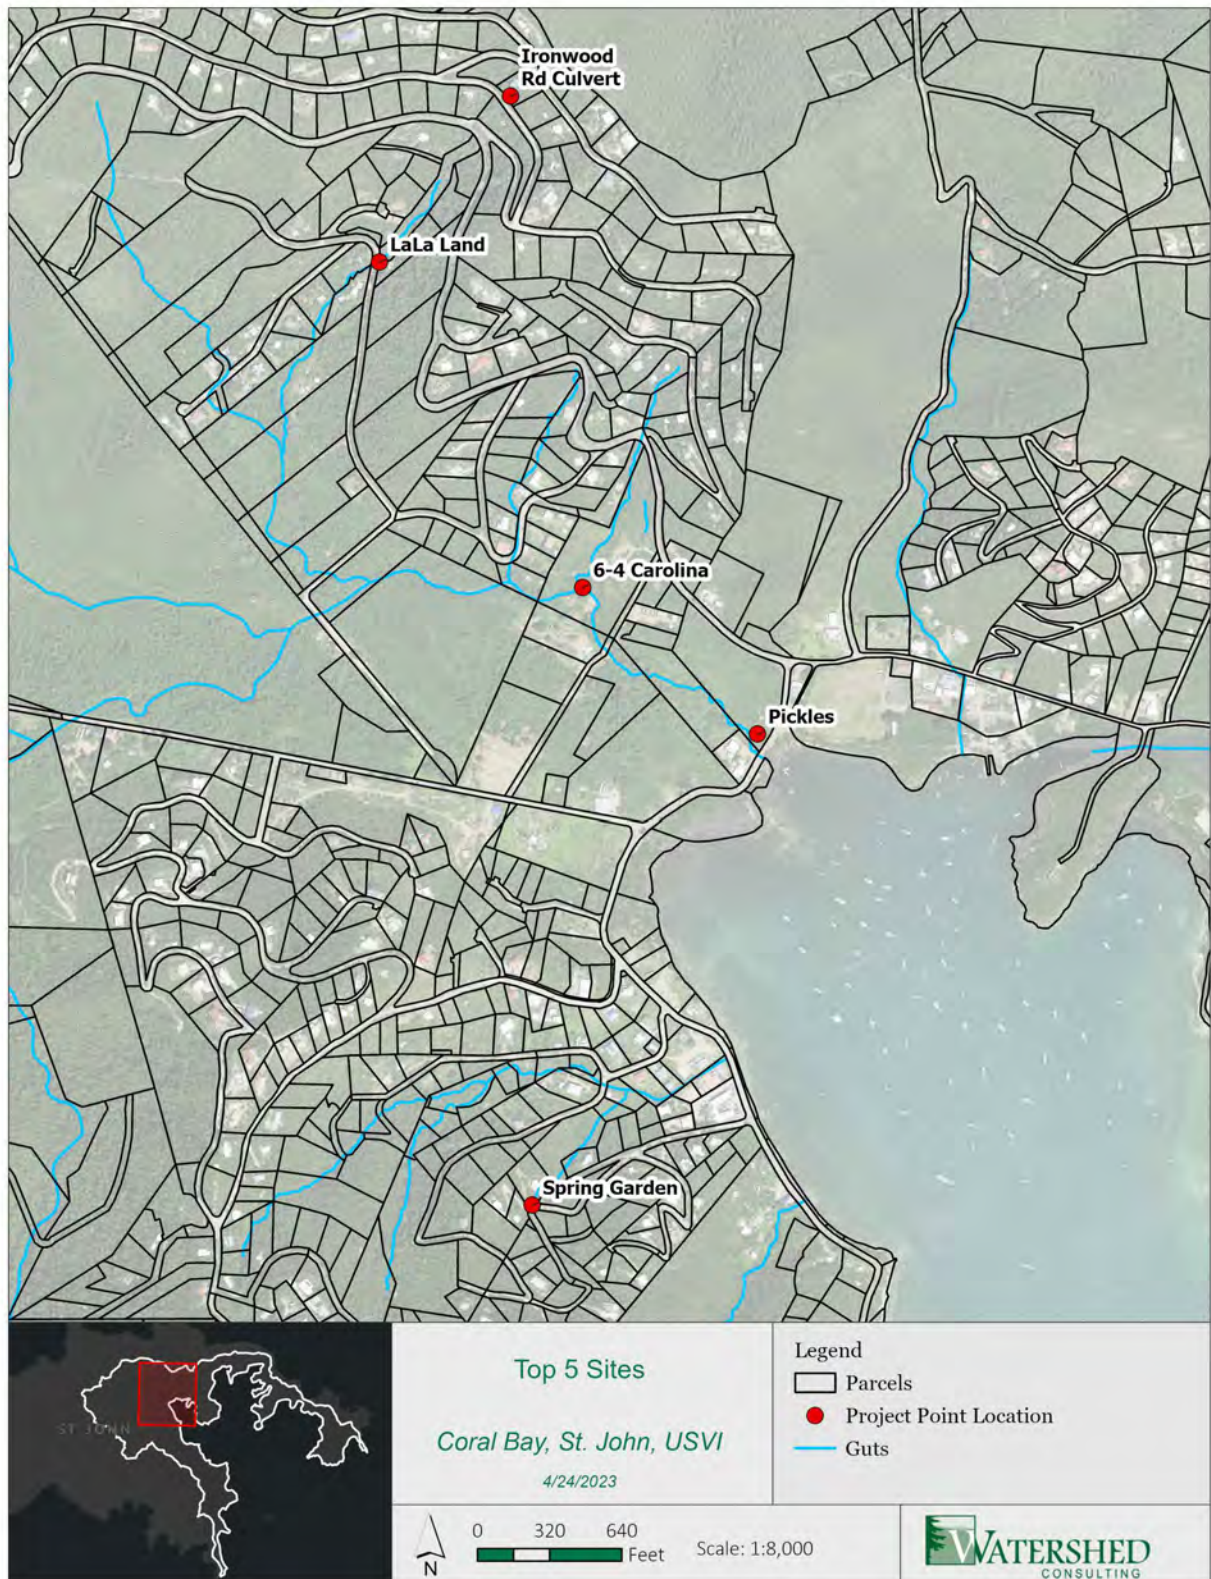
Figure 11. The five selected priority projects are indicated with a red circle.

One site, the Ironwood Rd Culvert, was pre-selected as a priority as CBCC released a request for proposals (RFP) for engineering design of the retrofit of this culvert to improve drainage as part of another FEMA VITEMA HMGP funded project. The other four sites that were selected include 6-4 Carolina, Pickles, Spring Garden, and Lala Land. Each of these project sites are described in detail below. The locations of the sites within the Coral Bay watershed can be viewed in Figure 11. All five sites are located in the central more developed area of Coral Bay. With the exception of Spring Garden, the remaining four sites all drain via the same main gut and, as such, the drainages for each of these four sites are related. From most upstream to most downstream, the projects are the Ironwood Road culvert, Lala Land, 6-4 Carolina, and Pickles.

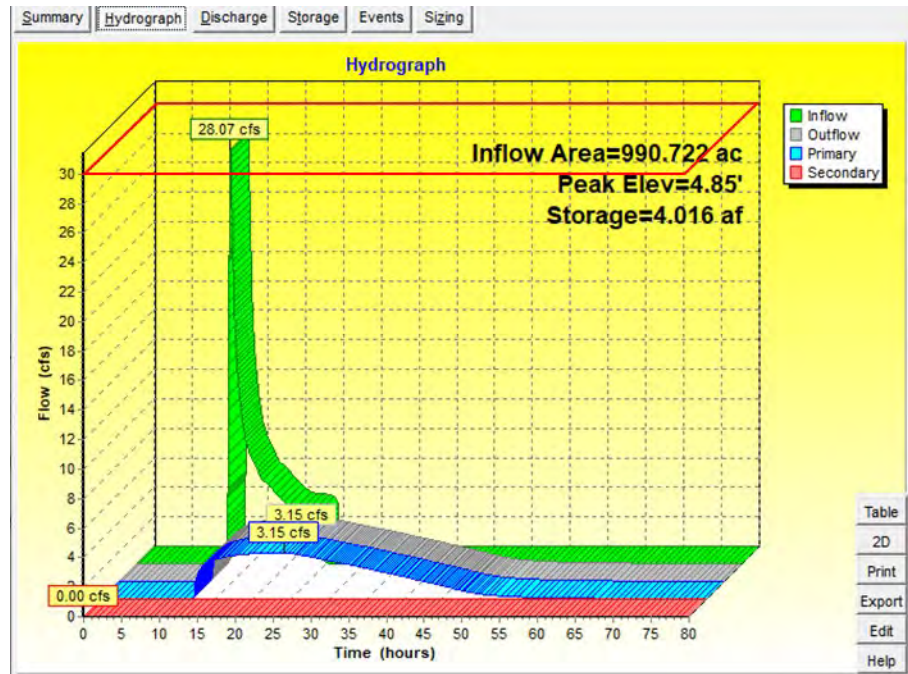
**Figure 14. Peak flows are reduced from 28.07 cfs (green line) to 3.15 cfs (gray line) with the addition of a stormwater basin during the one-inch storm event. A red line is shown at 30cfs to allow for easier comparison between graphs.**

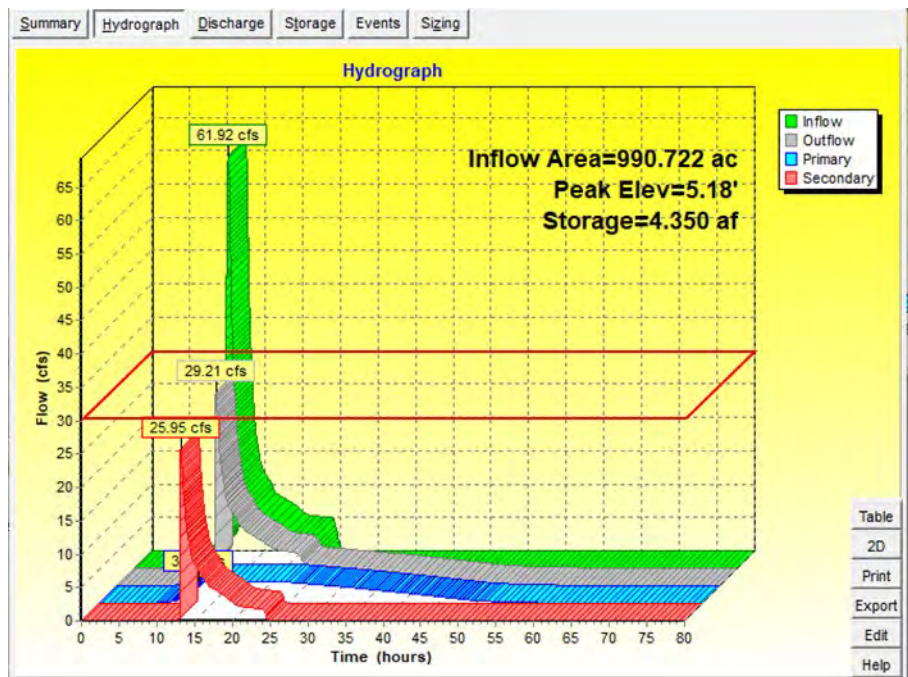
**Figure 14. Peak flows are reduced from 61.92 cfs (green line) to 29.21 cfs (gray line) with the addition of a stormwater basin during the 1.5-inch storm event. Peak flow from the primary outlet (blue line) is 3.26 cfs. A red line is shown at 30cfs to allow for easier comparison between graphs.**

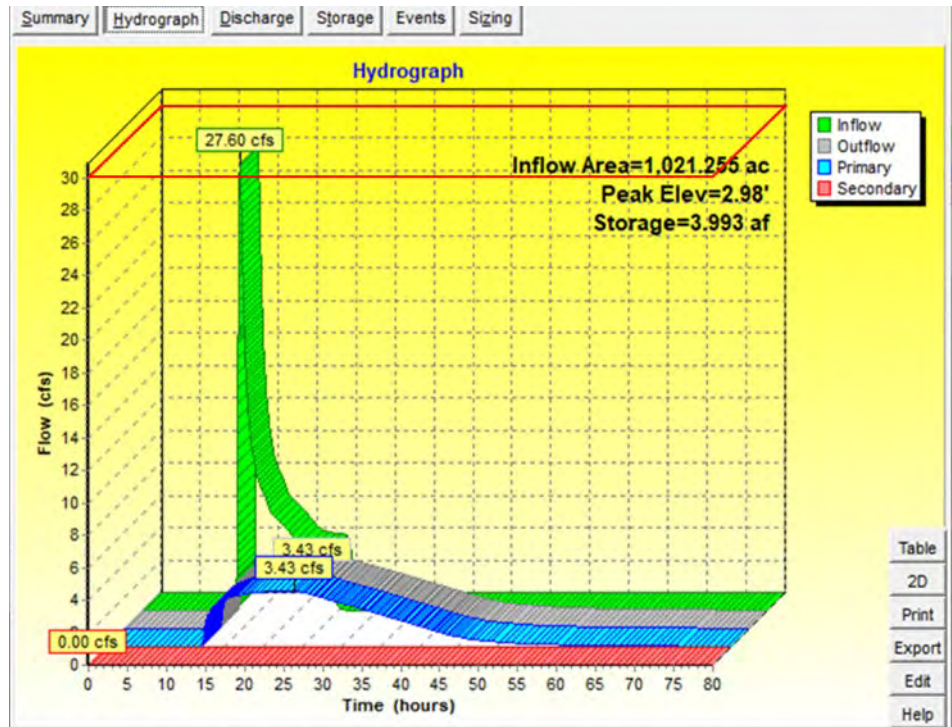
**Figure 19.** Peak flows are reduced from 27.6 cfs (green line) to 3.43 cfs (gray line) with the addition of a stormwater basin during the one-inch storm event. A red line is shown at 30cfs to allow for easier comparison between graphs.

but it also reduces the erosive potential of the stormwater flows. The hydrograph for this basin during this 1-year storm event can be found in Figure 19.

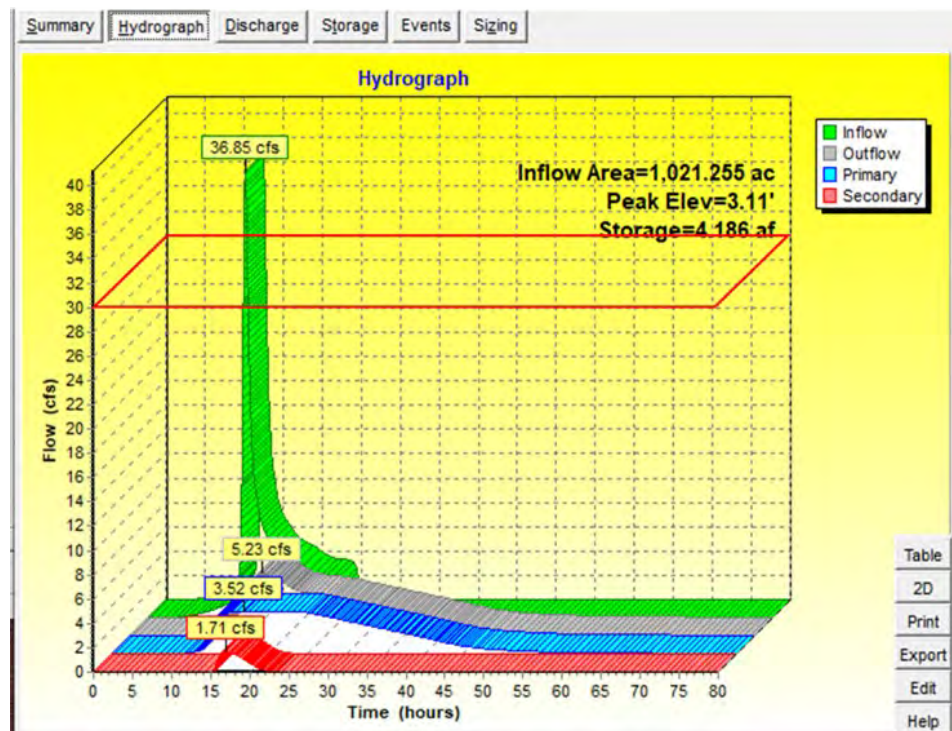
**Figure 19.** In the 1.25-inch storm event, peak flows decrease from 36.85 cfs (green line) to 5.23 cfs (gray line). A red line is shown at 30cfs to allow for easier comparison between graphs.

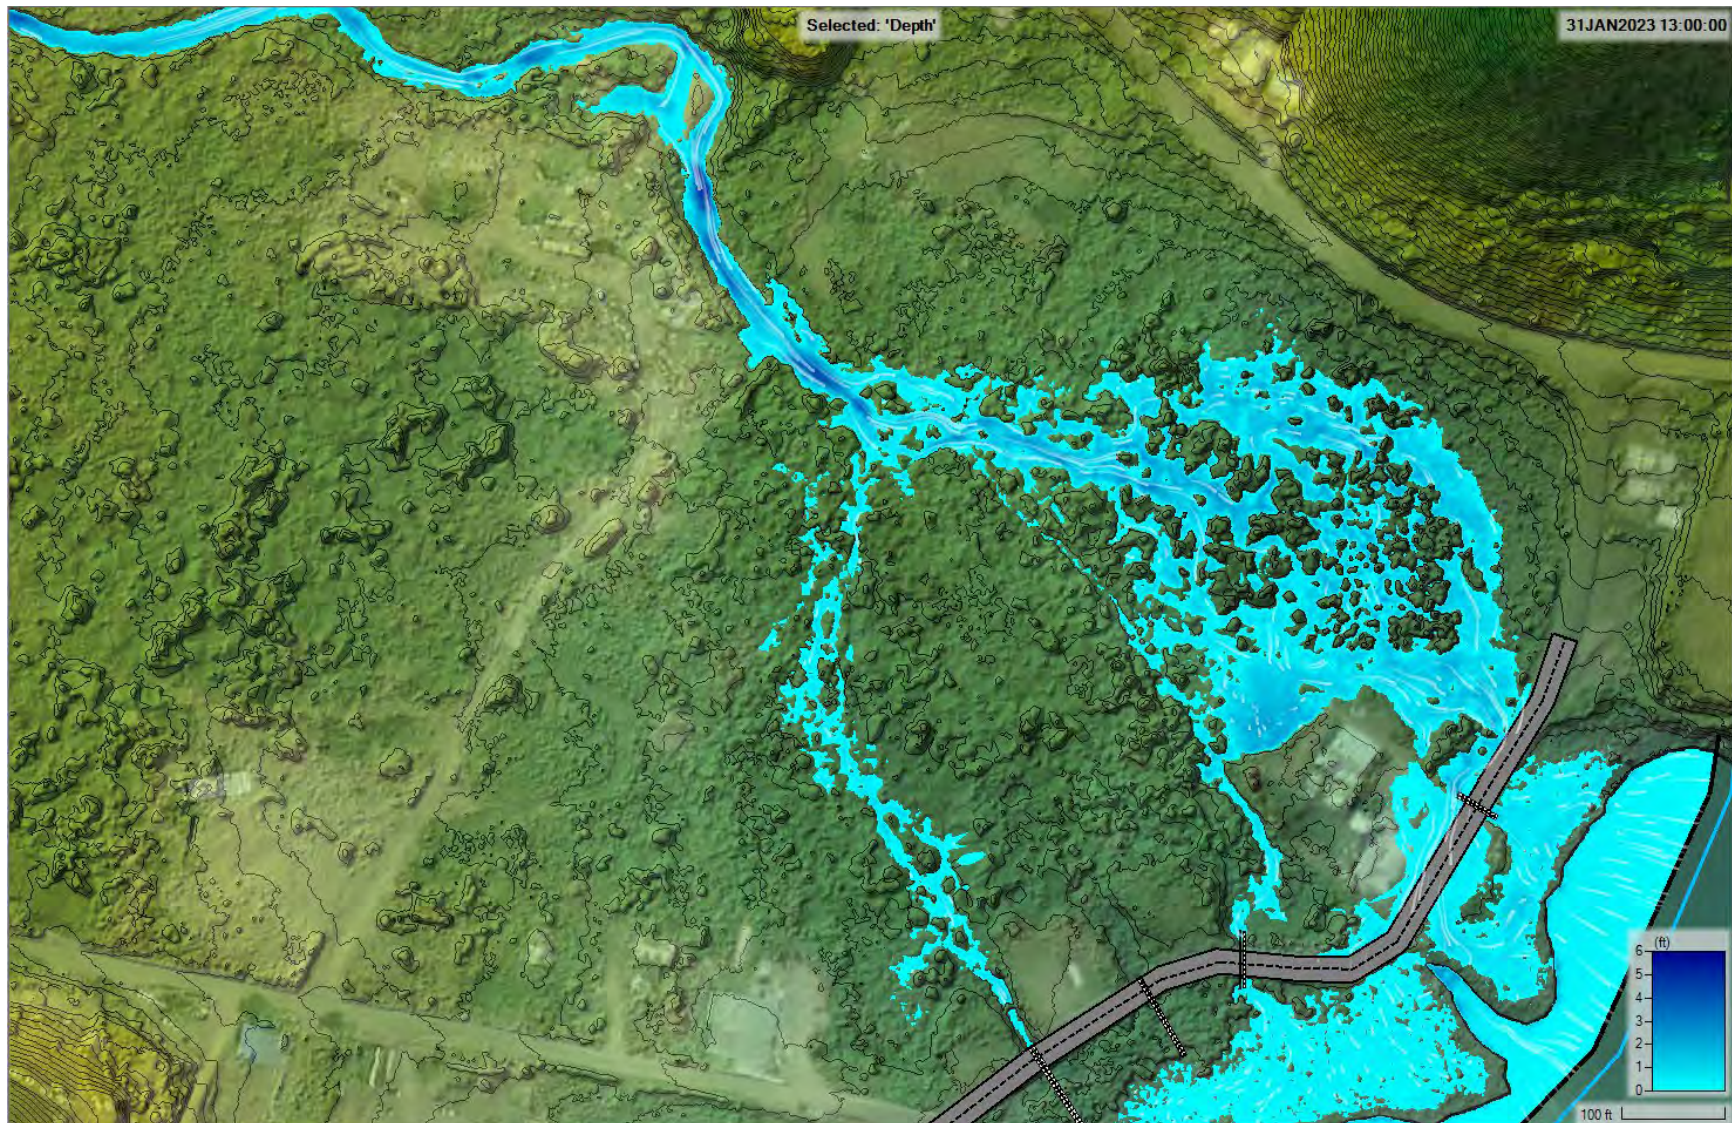
Figure 20. Flood depth during a 1.25-inch storm event at the Pickles site. Depth is indicated by blue shading with deeper flooding depths shown in darker blue. Note that water was observed flowing over the road in the model. The road is shown as a gray polygon due to how the model was prepared including the elevations of the road surface.

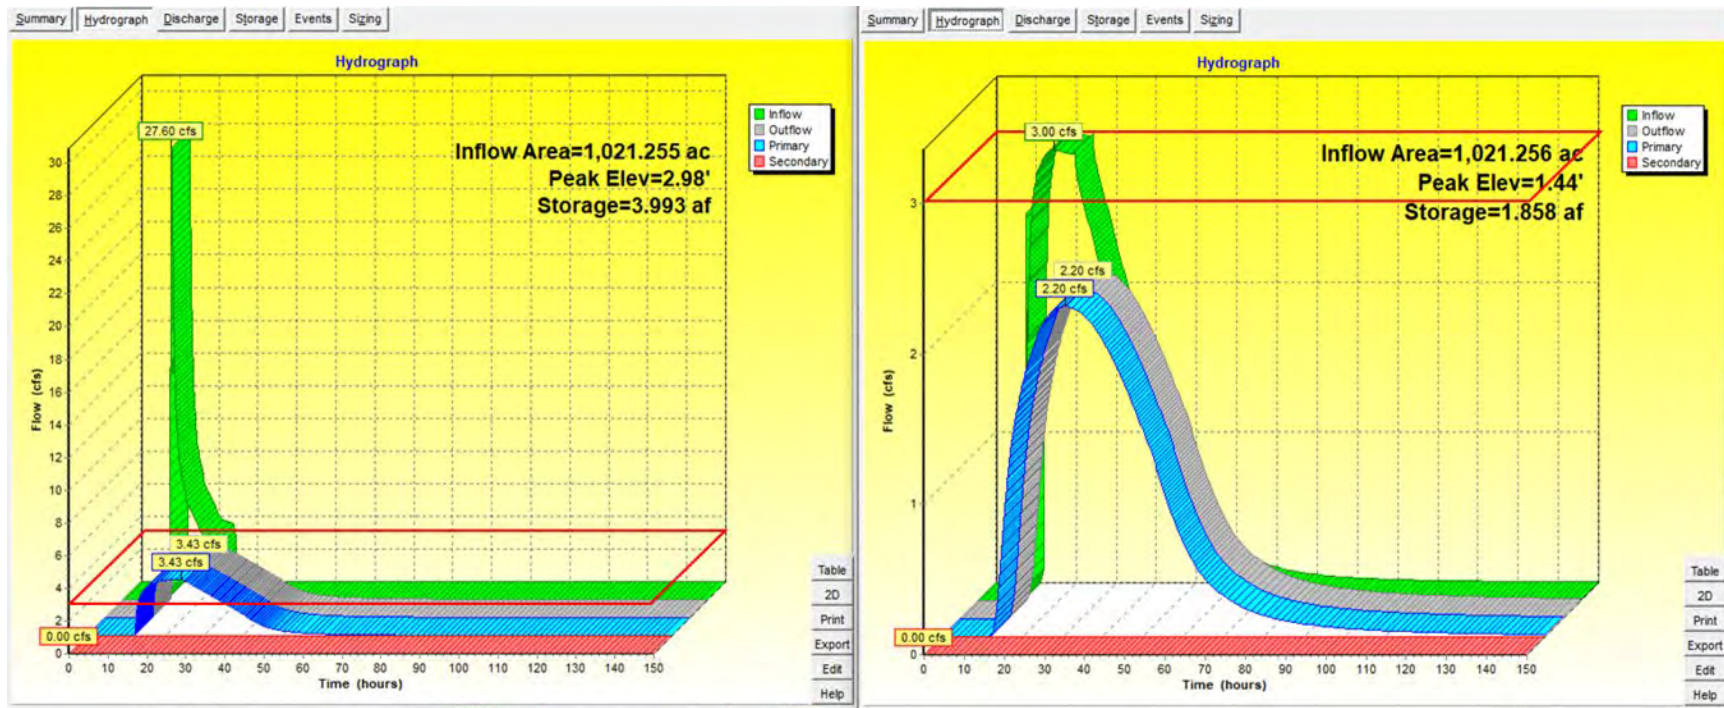
Figure 23. Peak flows during the 1-inch storm event are shown for the Pickles site with the proposed stormwater basin. The left graph shows the flows if no additional basins are constructed upstream of Pickles (inflow of 22.64 cfs; outflow of 3.43 cfs). The right graph shows the effect of implementation of the 6-4 Carolina basin (inflow of 3.0 cfs and outflow of 2.2 cfs). Also note that the depth of water in the basin is reduced from 2.98 ft (left) to 1.44 ft (right). Note that the y-axis scales are significantly different between the graphs. 3 cfs is highlighted with a red box on the hydrographs to illustrate this difference in scale.

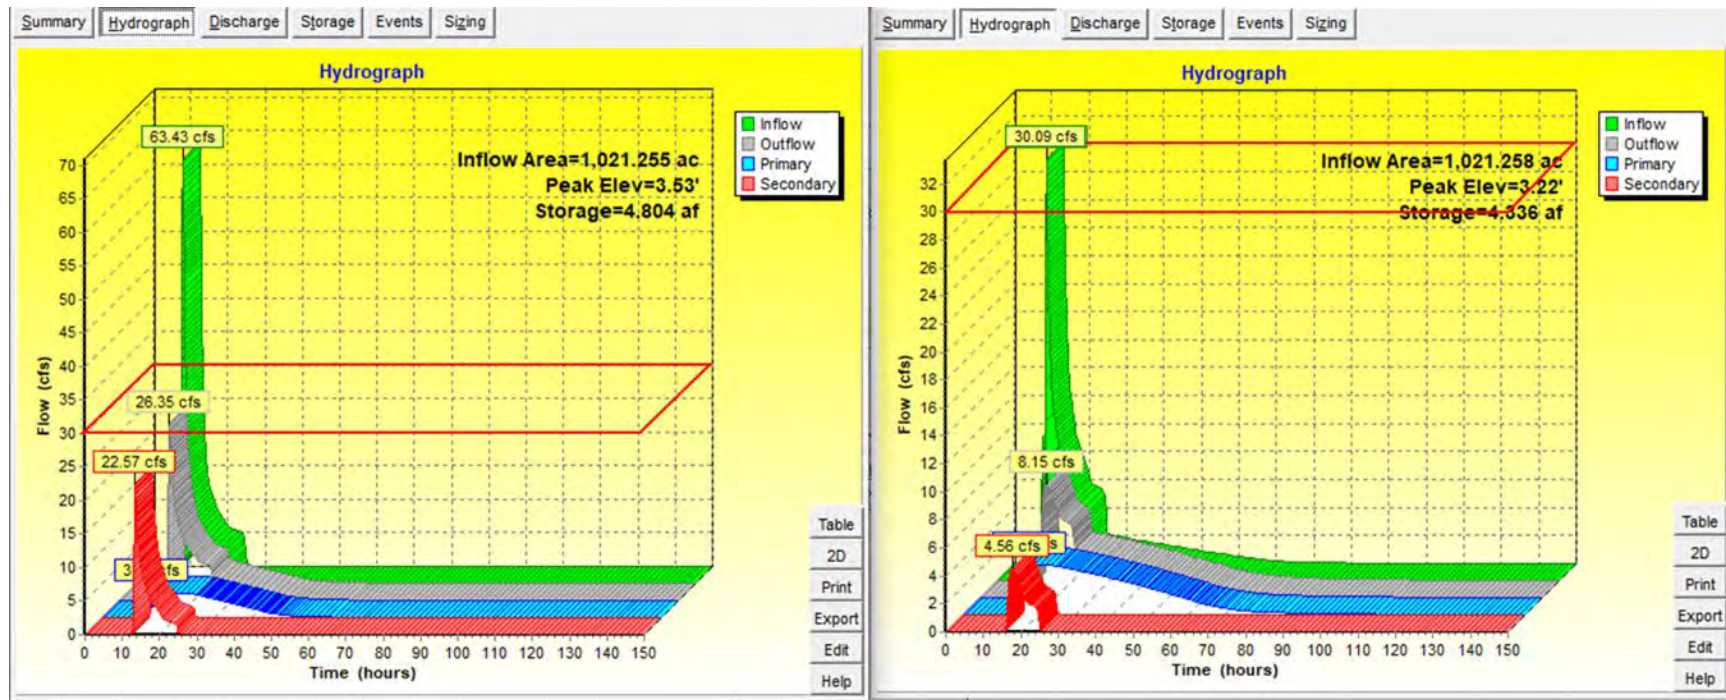
Figure 24. Peak flows during the 1.5-inch storm event are shown for the Pickles site. The left graph shows the flows if no additional basins are constructed (inflow of 63.43 cfs; outflow of 26.35 cfs). The right graph shows the effect of implementation of the 6-4 Ca Carolina basin (inflow of 30.09 cfs and outflow of 8.15 cfs). Also note that the depth of water in the basin is reduced from 3.53 ft (left) to 3.22 ft (right). Note that the y-axis scales are significantly different between the graphs. 30 cfs is highlighted with a red box on the hydrographs to illustrate this difference in scale.
