Hazard Mitigation  
Grant Program  
(HMGP) project  
number 4340-0054:  
Coral Bay Hydrology  
and Hydraulics (H&H)

Final Report  
September 2023

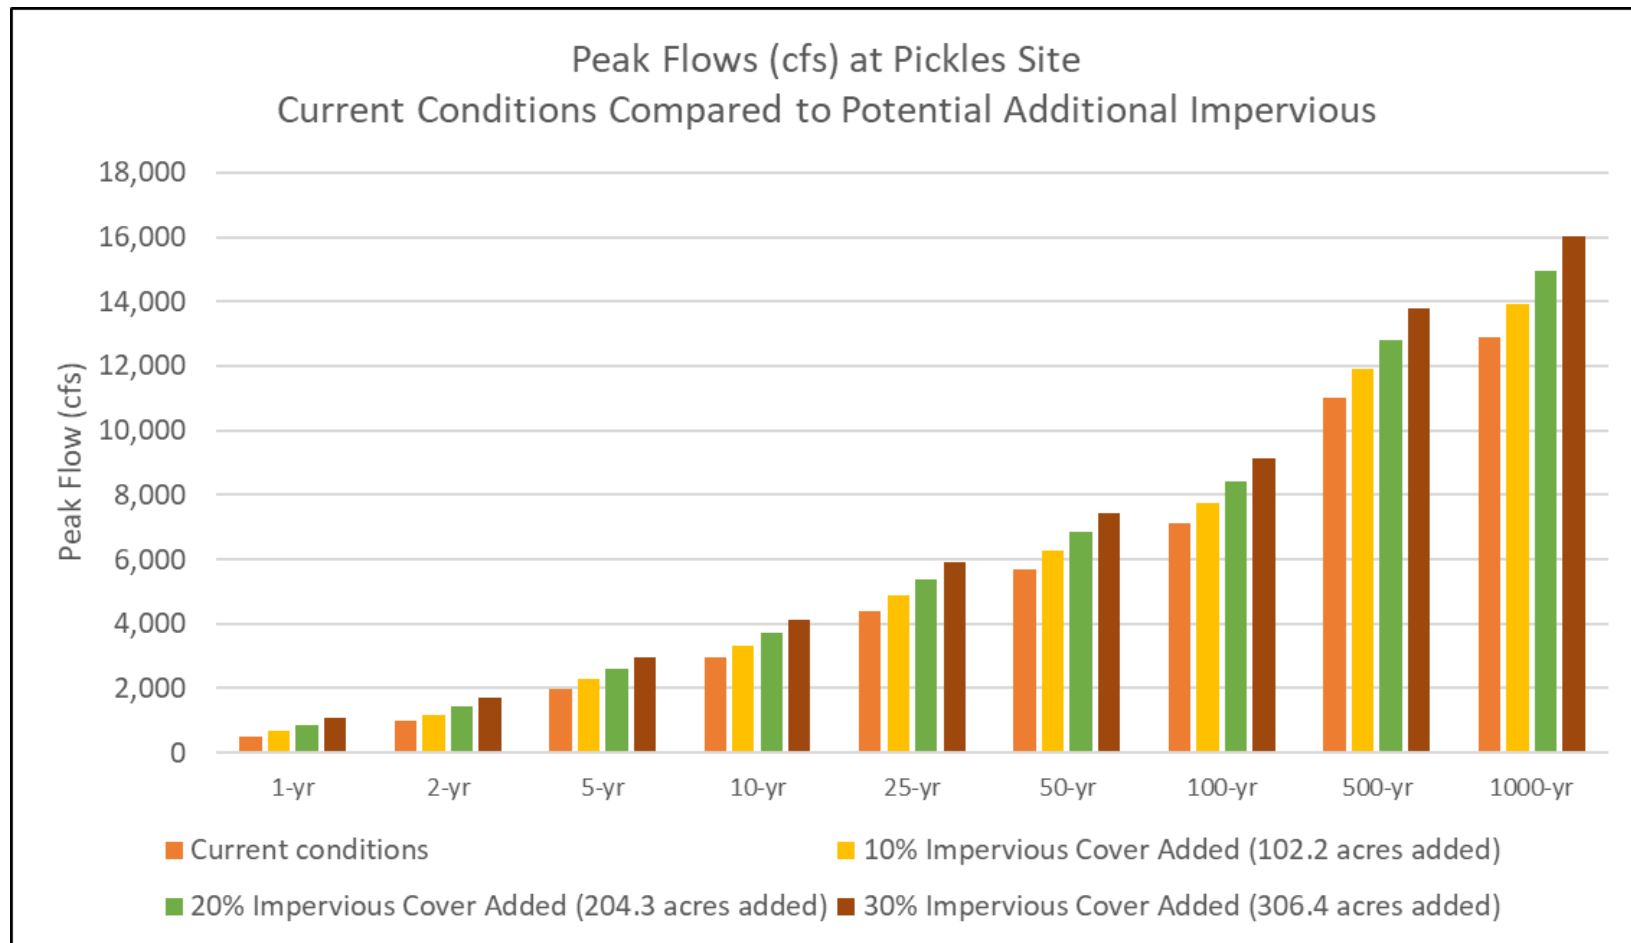
**Figure 25. Peak flows (cfs) in the Pickles drainage area are compared with varying levels of additional impervious cover.**

An assessment was completed to determine the impact of additional development within the watershed resulting in the conversion of vegetated (forested) areas to impervious cover. Within the drainage area, forested land cover was reduced proportionally depending on hydrologic soil group and converted to impervious. The existing condition (50.62 acres impervious) were compared to scenarios where impervious is increased by 10% (total of 152.8 acres impervious), 20% (total of 254.9 acres impervious), and 30% (total of 357 acres impervious). Peak flows for these scenarios are shown in Figure 25. Modeled peak flows increase significantly with the addition of this impervious cover within the drainage area.

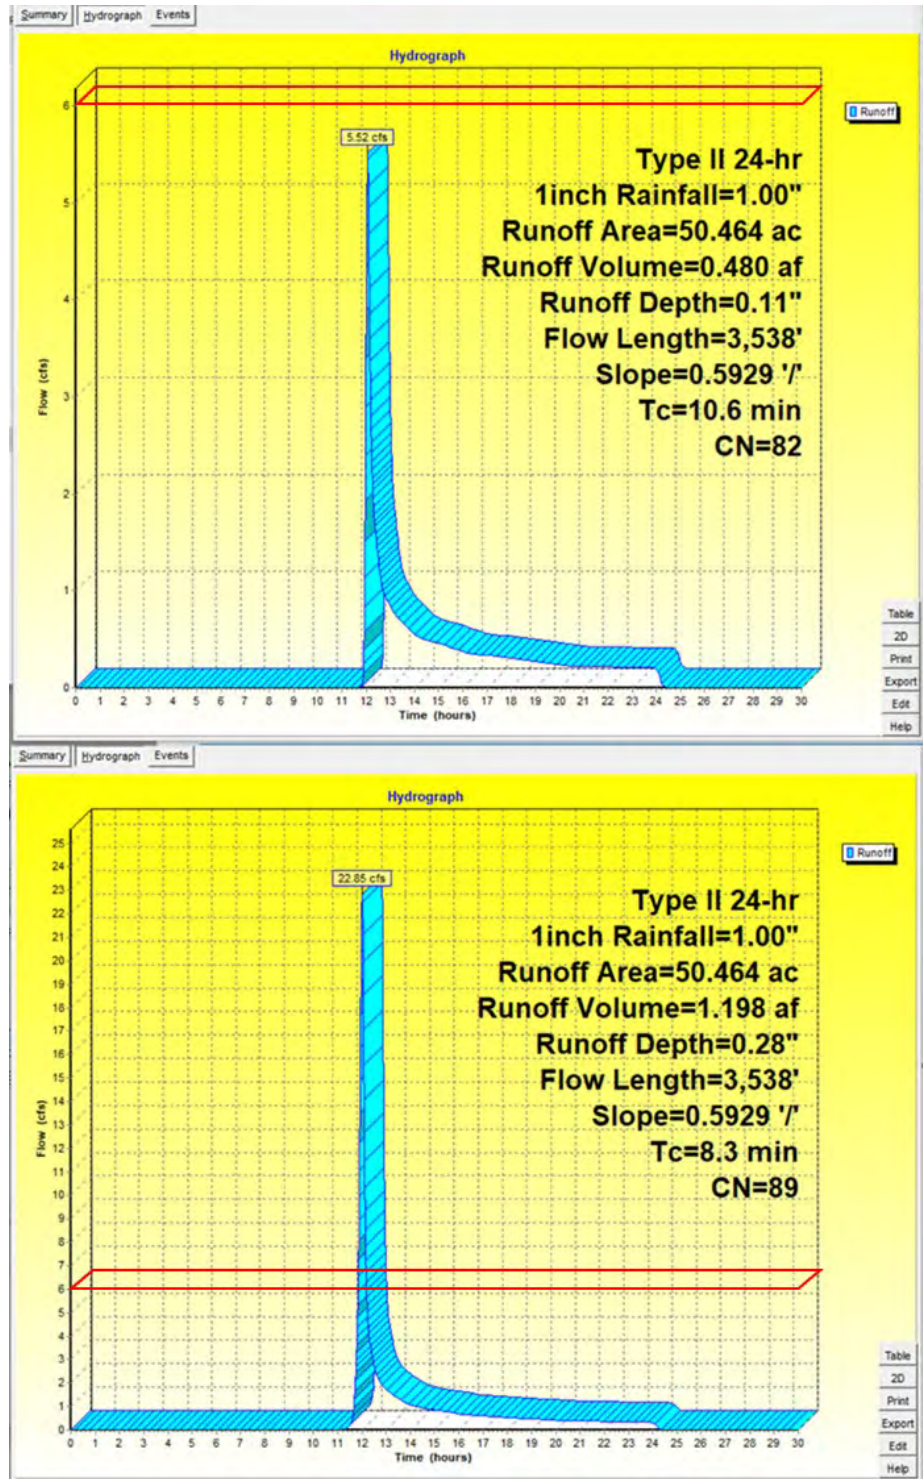
**Figure 28. Peak flows during the water quality storm event (1-inch of rainfall in a 24-hour period) with existing conditions (upper) and with conversion of 9 acres of pervious cover to impervious (lower). Note that the y-axis scales are significantly different between the graphs. Six cfs is highlighted with a red box on the hydrographs to illustrate this difference in scale.**

The peak flow increase can be seen visually on the hydrograph produced in HydroCAD in Figure 28. Note that the runoff volume in this storm event increases significantly from 0.48 acre-feet to 1.2 acre-feet with conversion of these 9 acres to impervious cover as less stormwater is being intercepted and infiltrated by pervious vegetated surfaces. While this increase in stormwater peak flow and volume is conceptual at this time, it strongly supports the need to limit development in this area and, if development does occur, ensure that it is well planned out with proper stormwater controls.

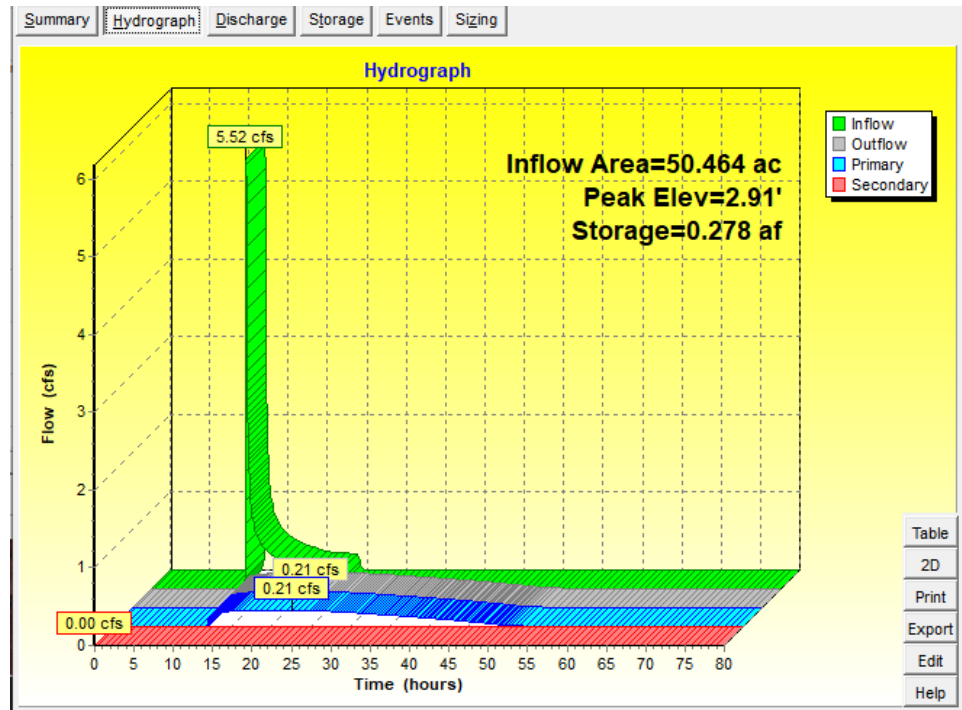
**Figure 29. Peak flows are reduced from 5.52 cfs (green line) to 0.21 cfs (gray line) with the addition of a stormwater basin during the one-inch storm event.**

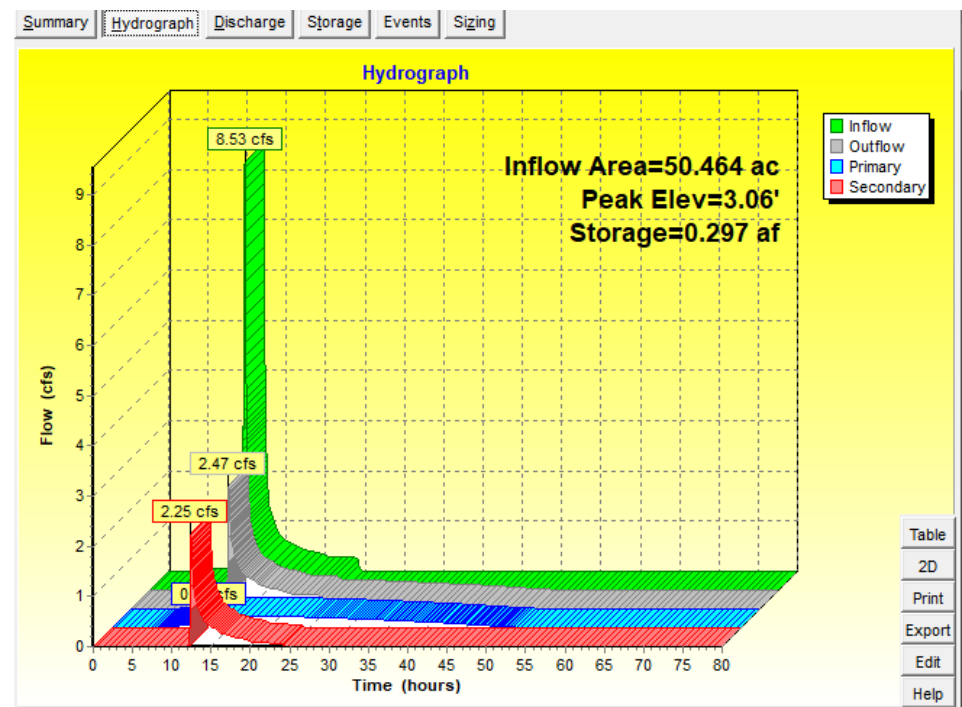
**Figure 30. In the 1.5-inch storm event, peak flows decrease from 8.53 cfs (green line) to 2.47 cfs (gray line). The peak flow from the primary outlet (blue line) was 0.22 cfs.**

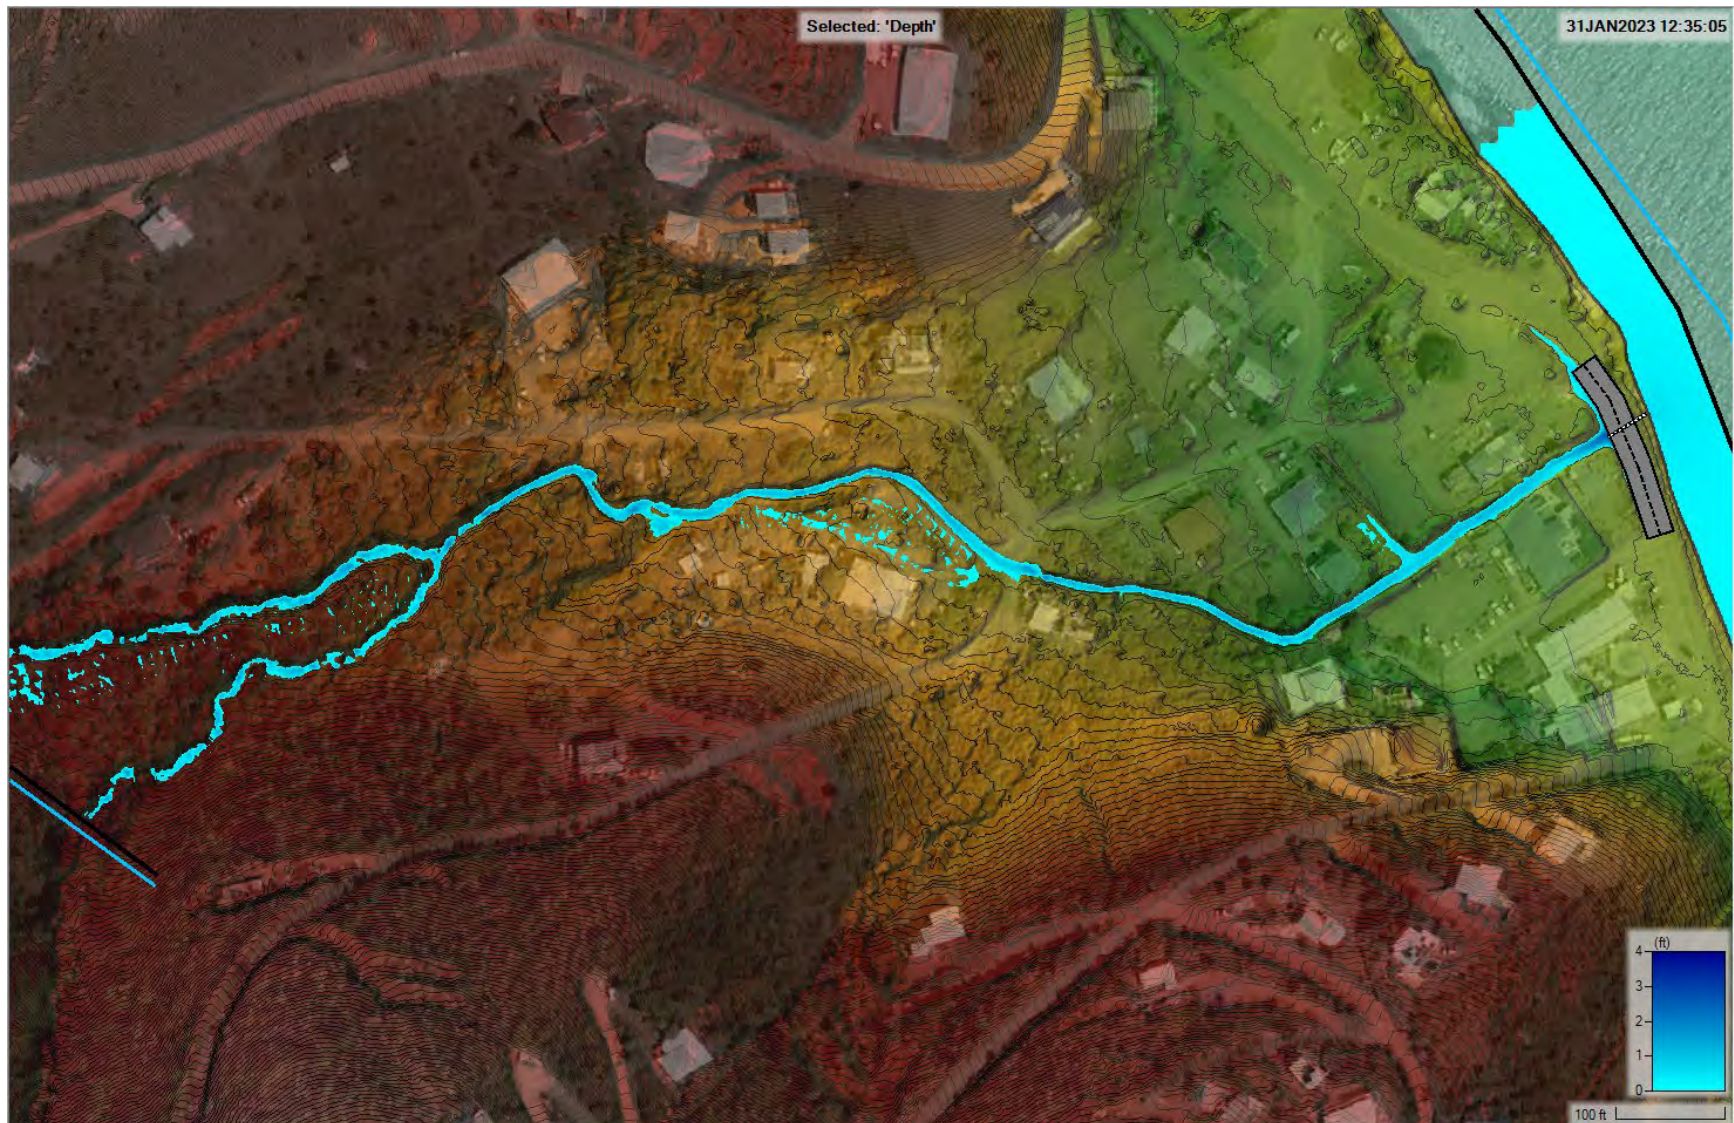
**Figure 31. Flood depth during a 1.5-inch storm event at the Spring Garden site. Depth is indicated by blue shading with deeper water depths shown in darker blue.**

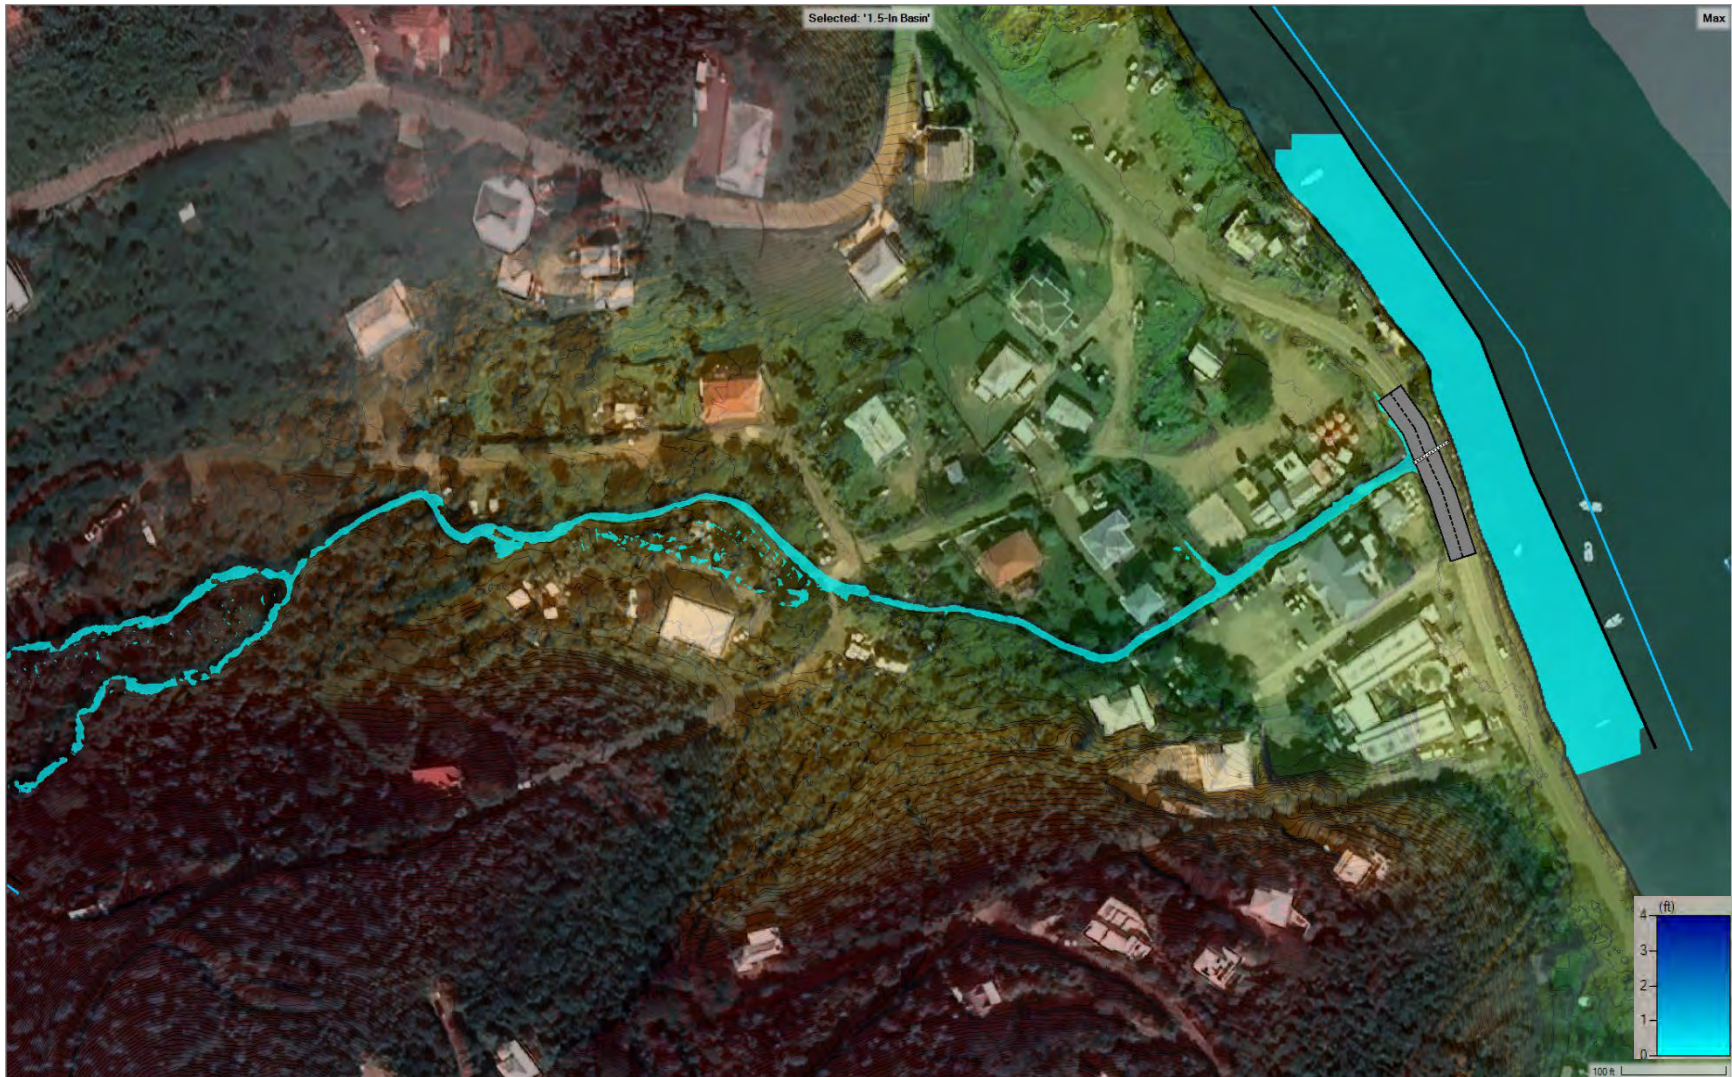
Figure 32. Flood depth during a 1.5-inch storm event at the Spring Garden site with the proposed stormwater basin in place. Depth is indicated by blue shading with deeper water depths shown in darker blue.

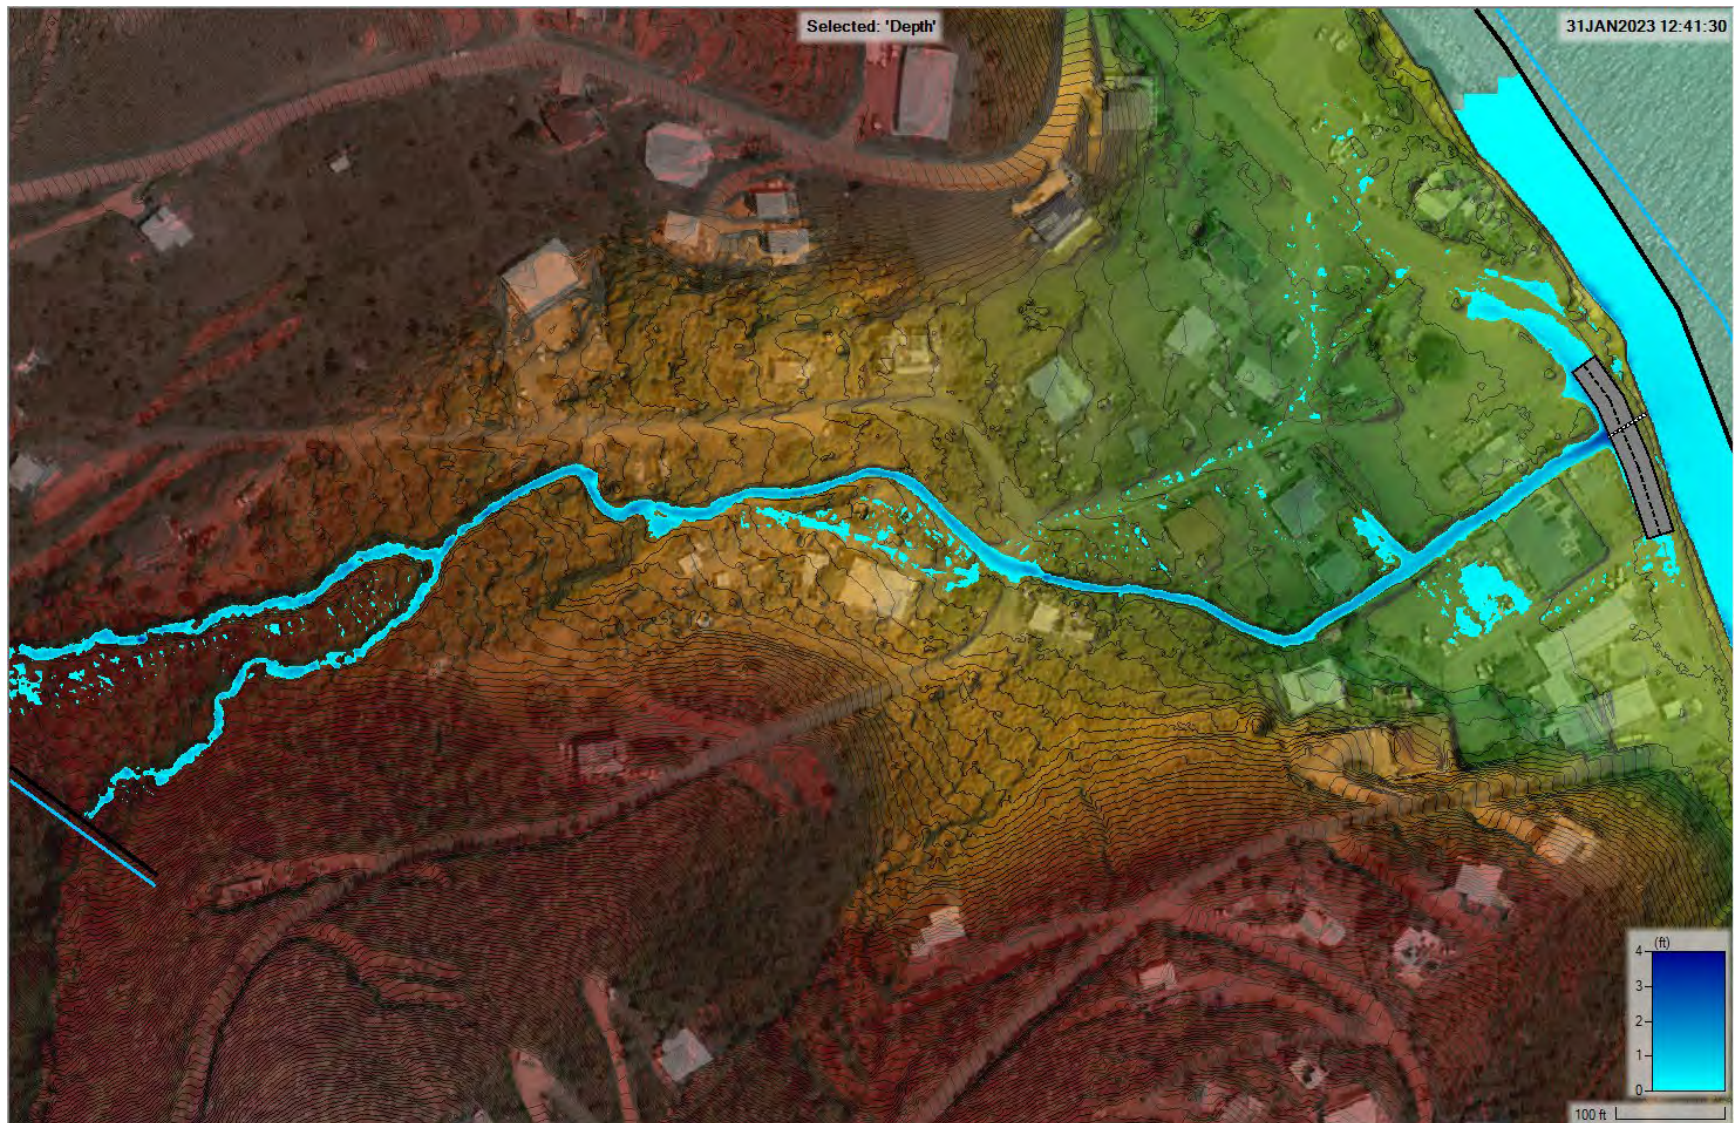
**Figure 33. Flood depth during a 2-inch storm event at the Spring Garden site. Depth is indicated by blue shading with deeper flooding depths shown in darker blue.**

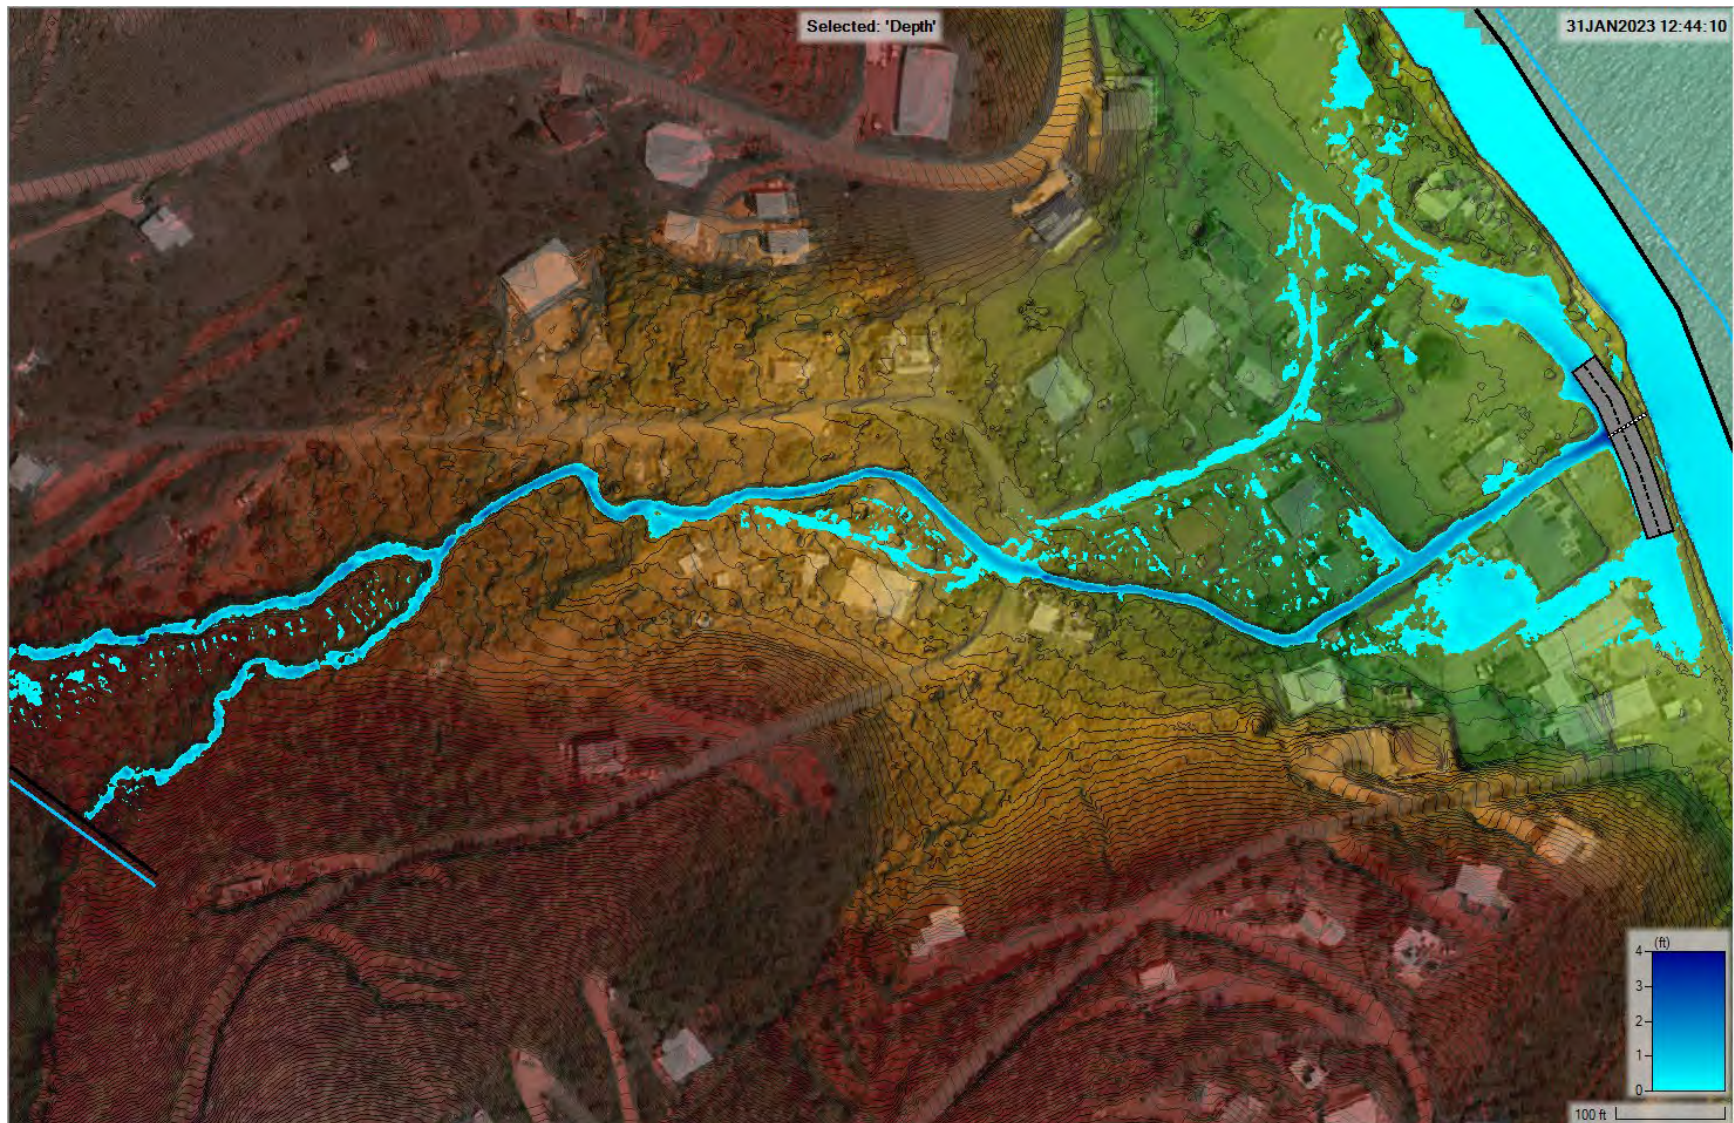
Figure 34. Flood depth during a 2.5-inch storm event at the Spring Garden site. Depth is indicated by blue shading with deeper flooding depths shown in darker blue.

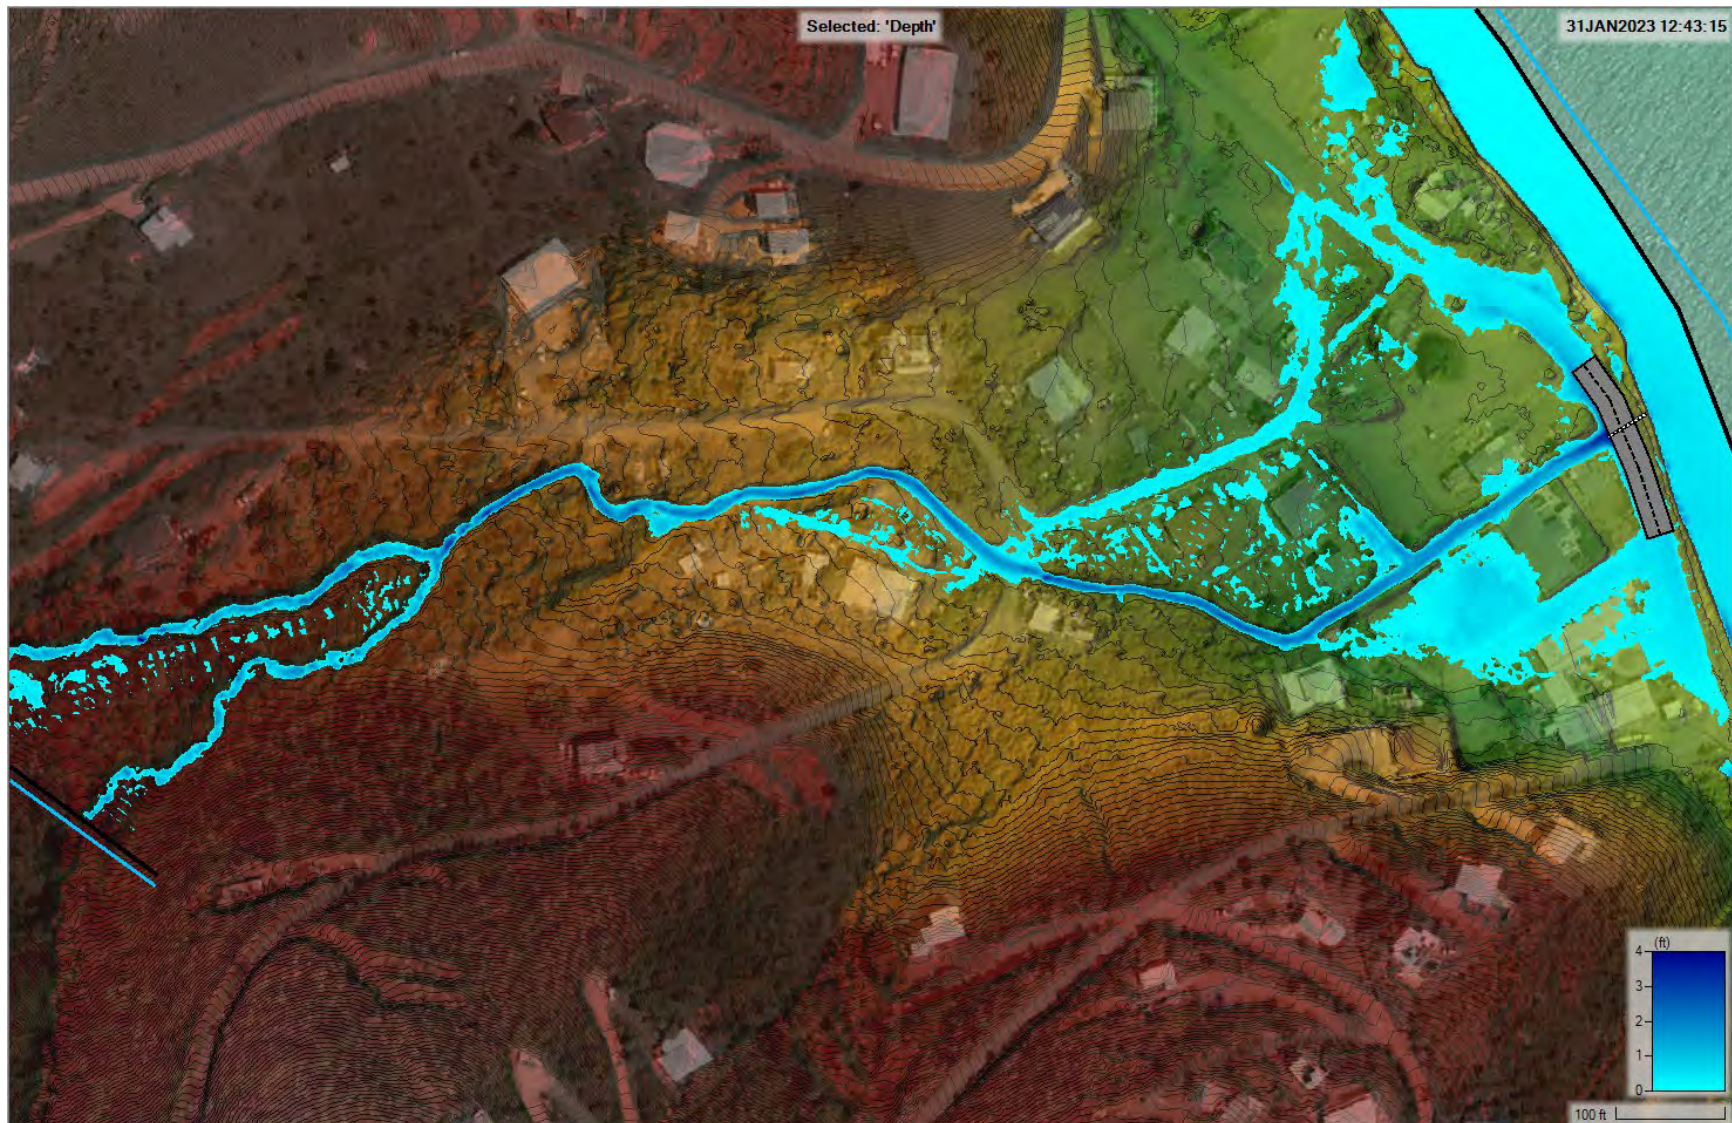
Figure 35. Flood depth during a 1-year (3.11-inch) storm event at the Spring Garden site. Depth is indicated by blue shading with deeper flooding depths shown in darker blue.

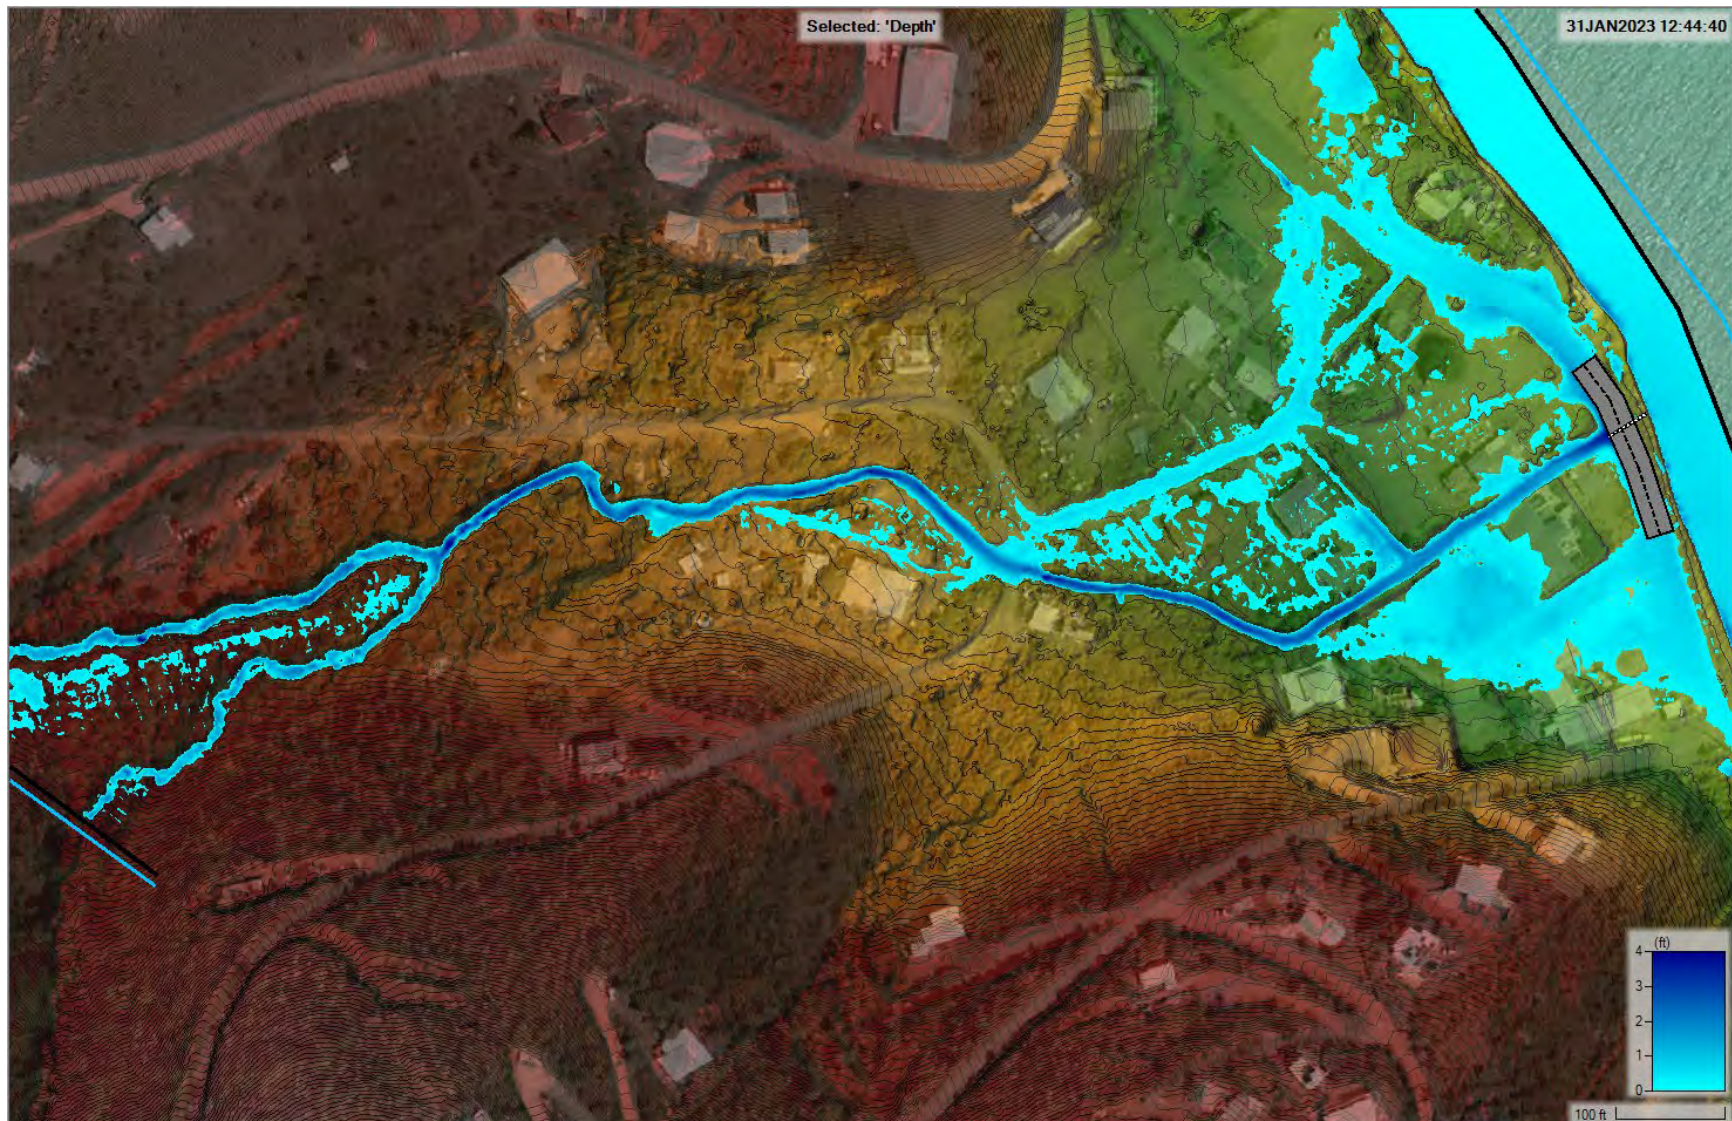
Figure 36. Flood depth during a 2-year (4.23-inch) storm event at the Spring Garden site. Depth is indicated by blue shading with deeper flooding depths shown in darker blue.

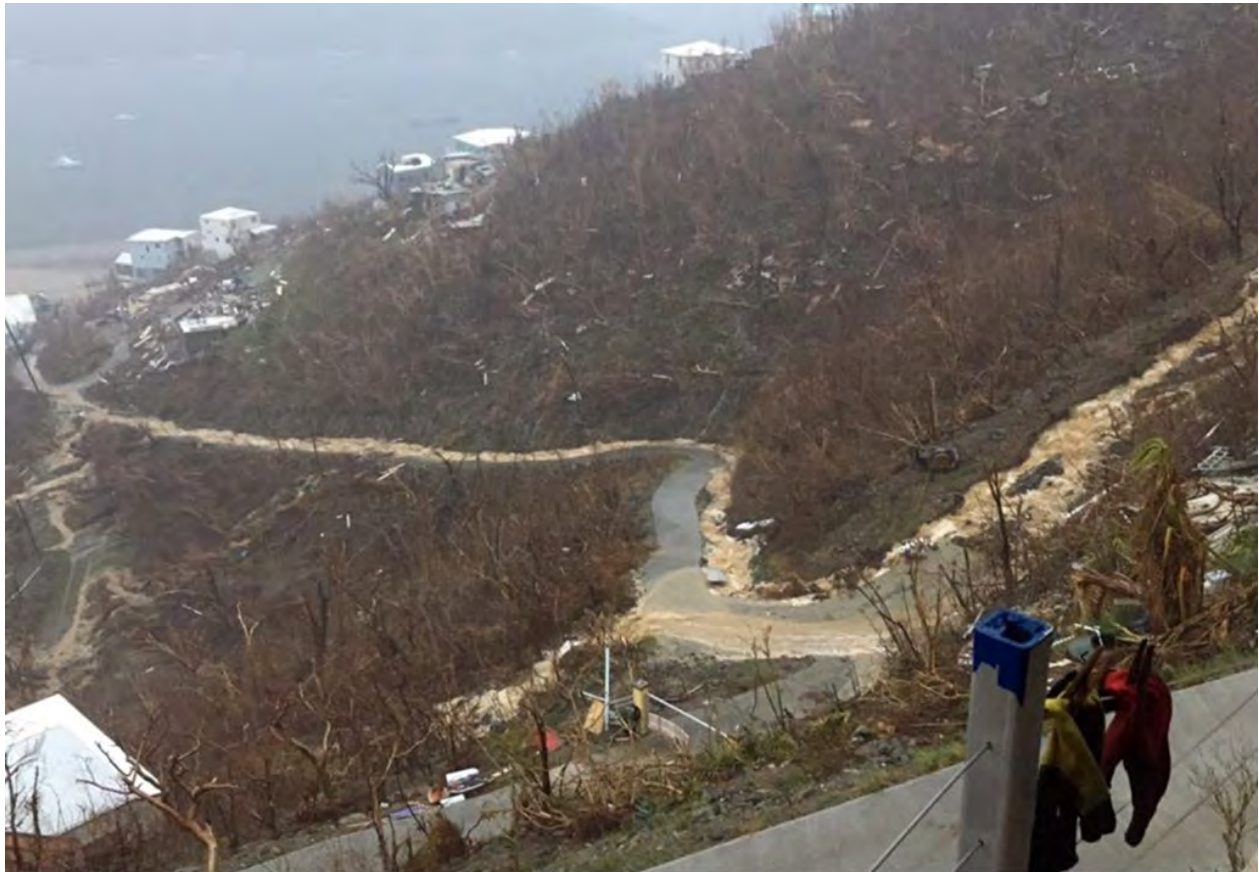
**Figure 37. The cleared road right-of-way (right of photo) funnels turbid water across and down Harold's Way in storm events (Photo by CBCC).**

The other components of the proposed retrofits for this site focus on the gut that runs through the eastern section of the valley. Currently, a road right-of-way has been cleared at the top of Harold's Way. The right-of-way includes a steep slope that funnels stormwater onto and down Harold's Way instead of to the stable gut channel (Figure 37).

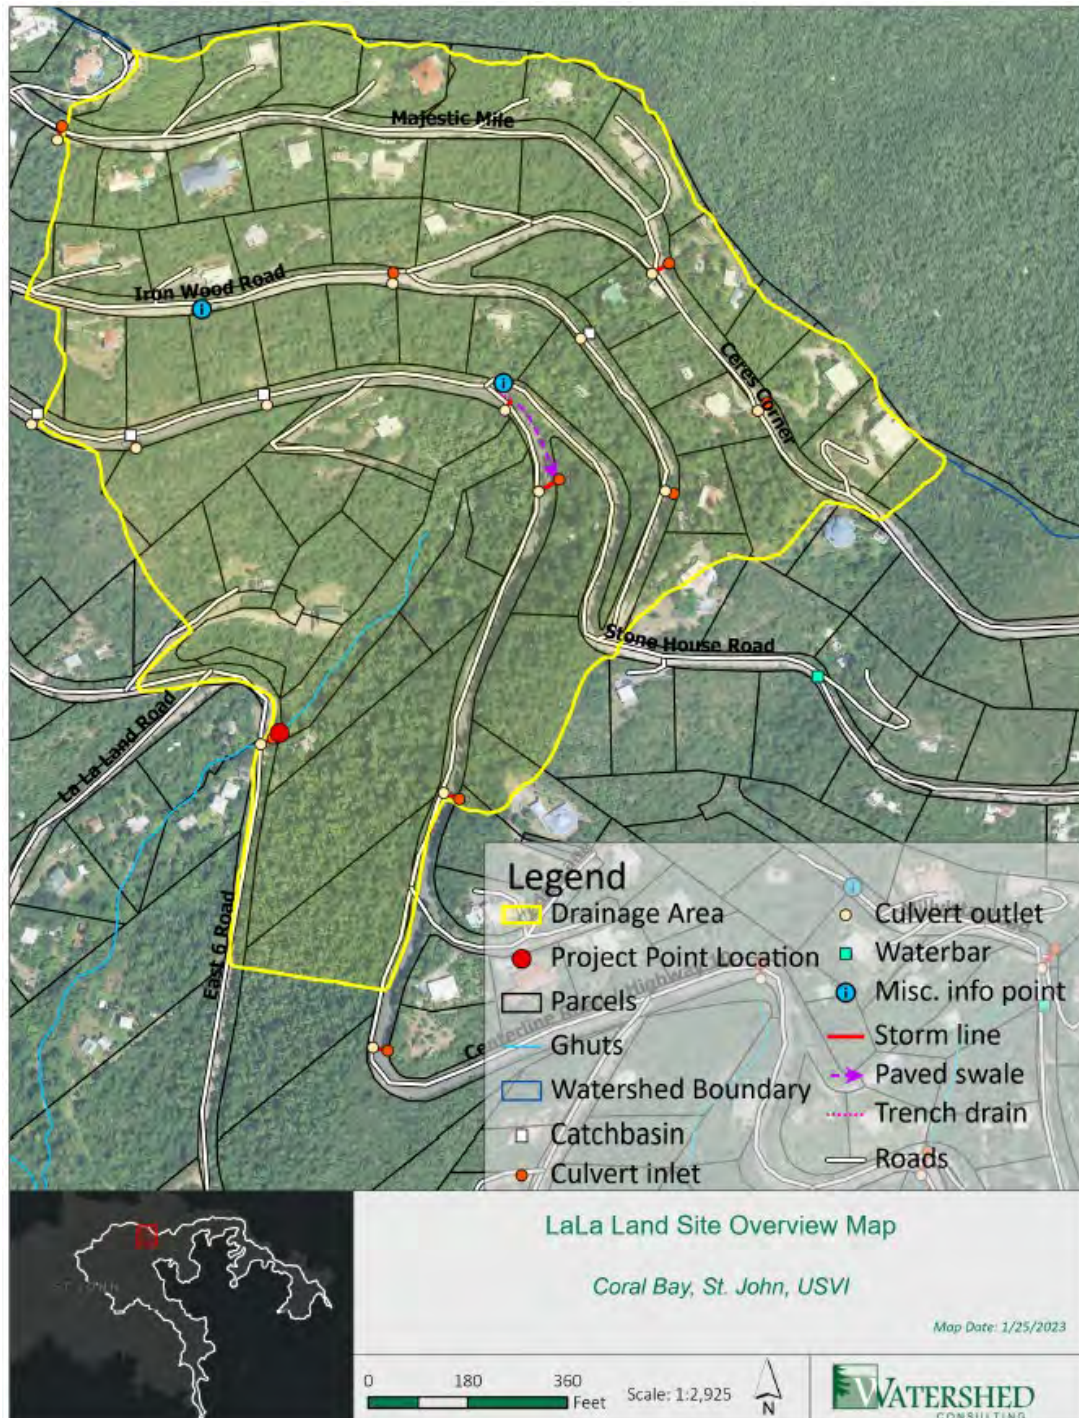
Figure 39. The Lala Land drainage area, highlighted in yellow, includes 36 acres of residential development. The site location is shown with a red circle.

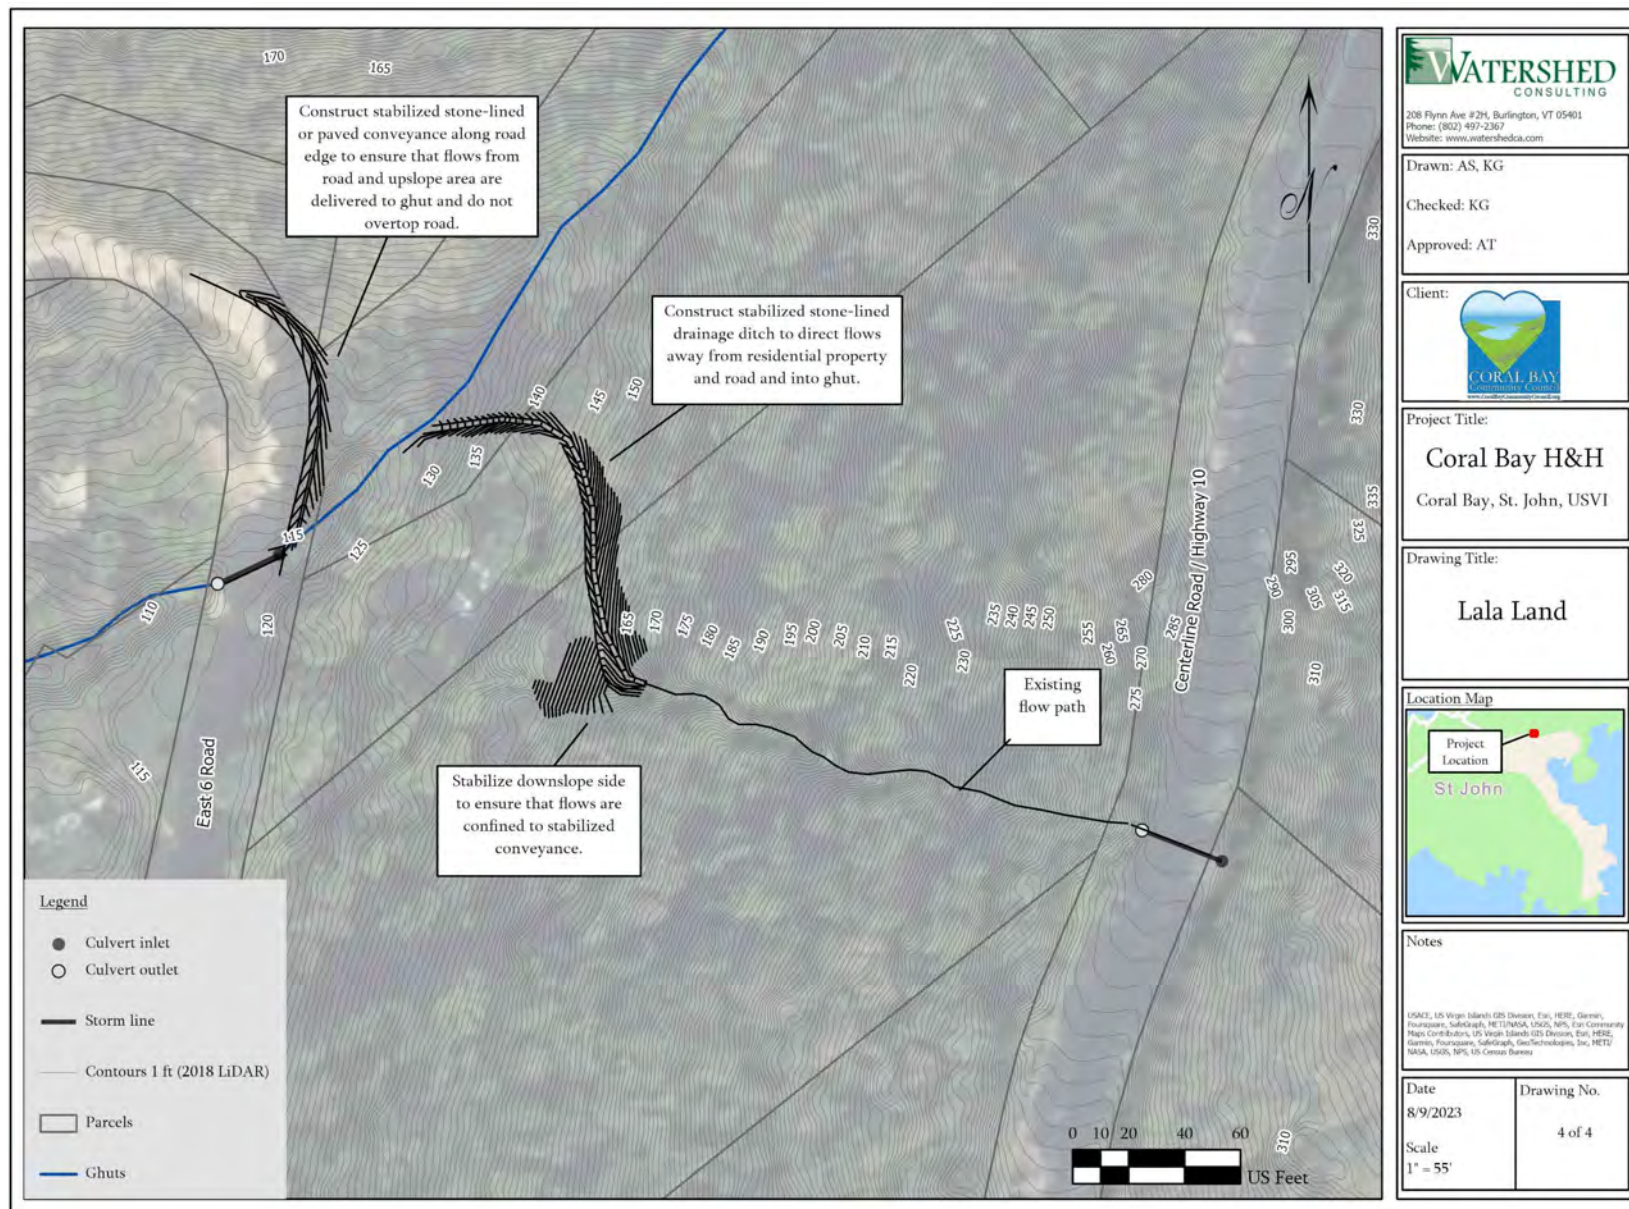
Figure 42. Proposed retrofits for the Lala Land site.

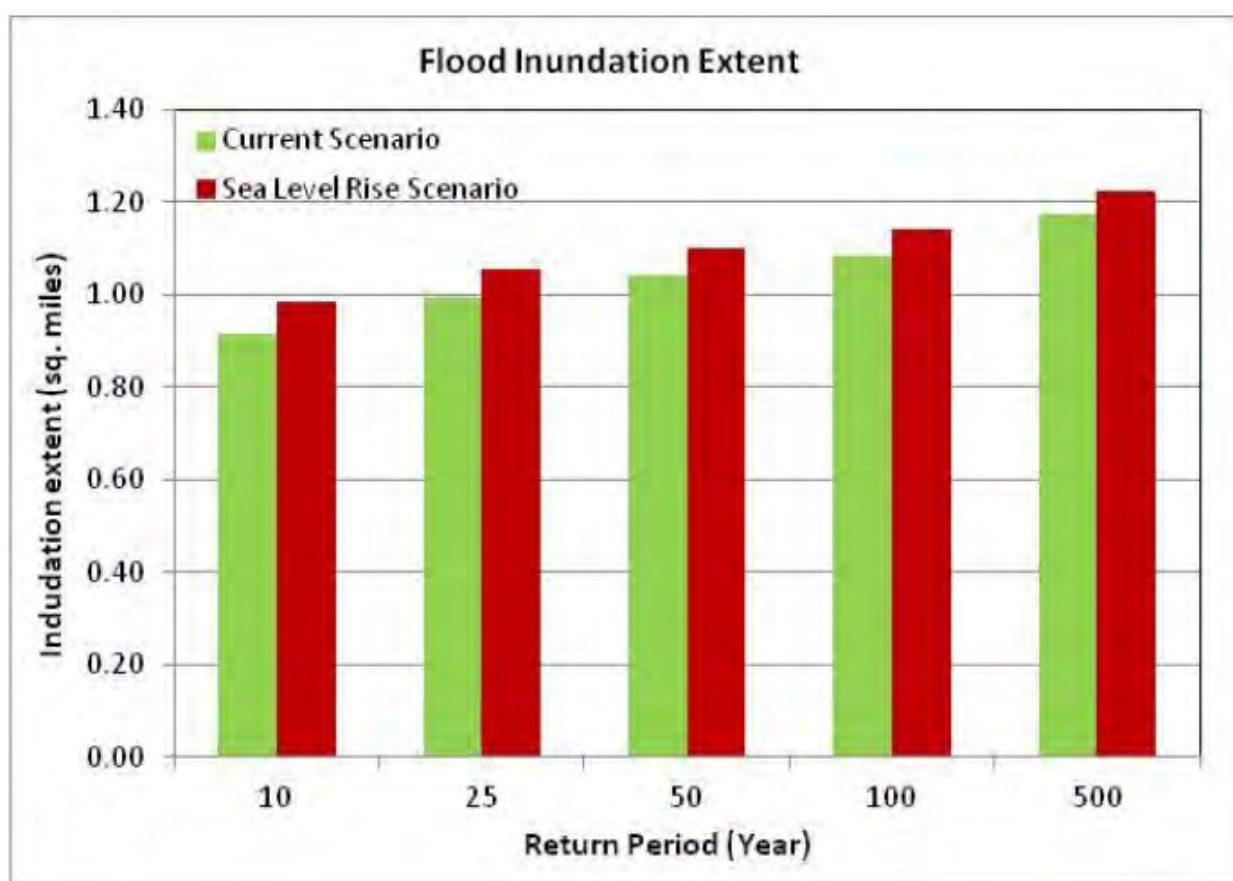
Figure 44. Change in flood inundation area due to sea level rise for the entirety of St. John (figure reproduced from RMSI, 2021).
